Strawberry Run Downstream Forensic Investigation

JUNE 27, 2022

Environmental Policy Commission

Presented by: Troy Biggs, PE, PH, D.WRE

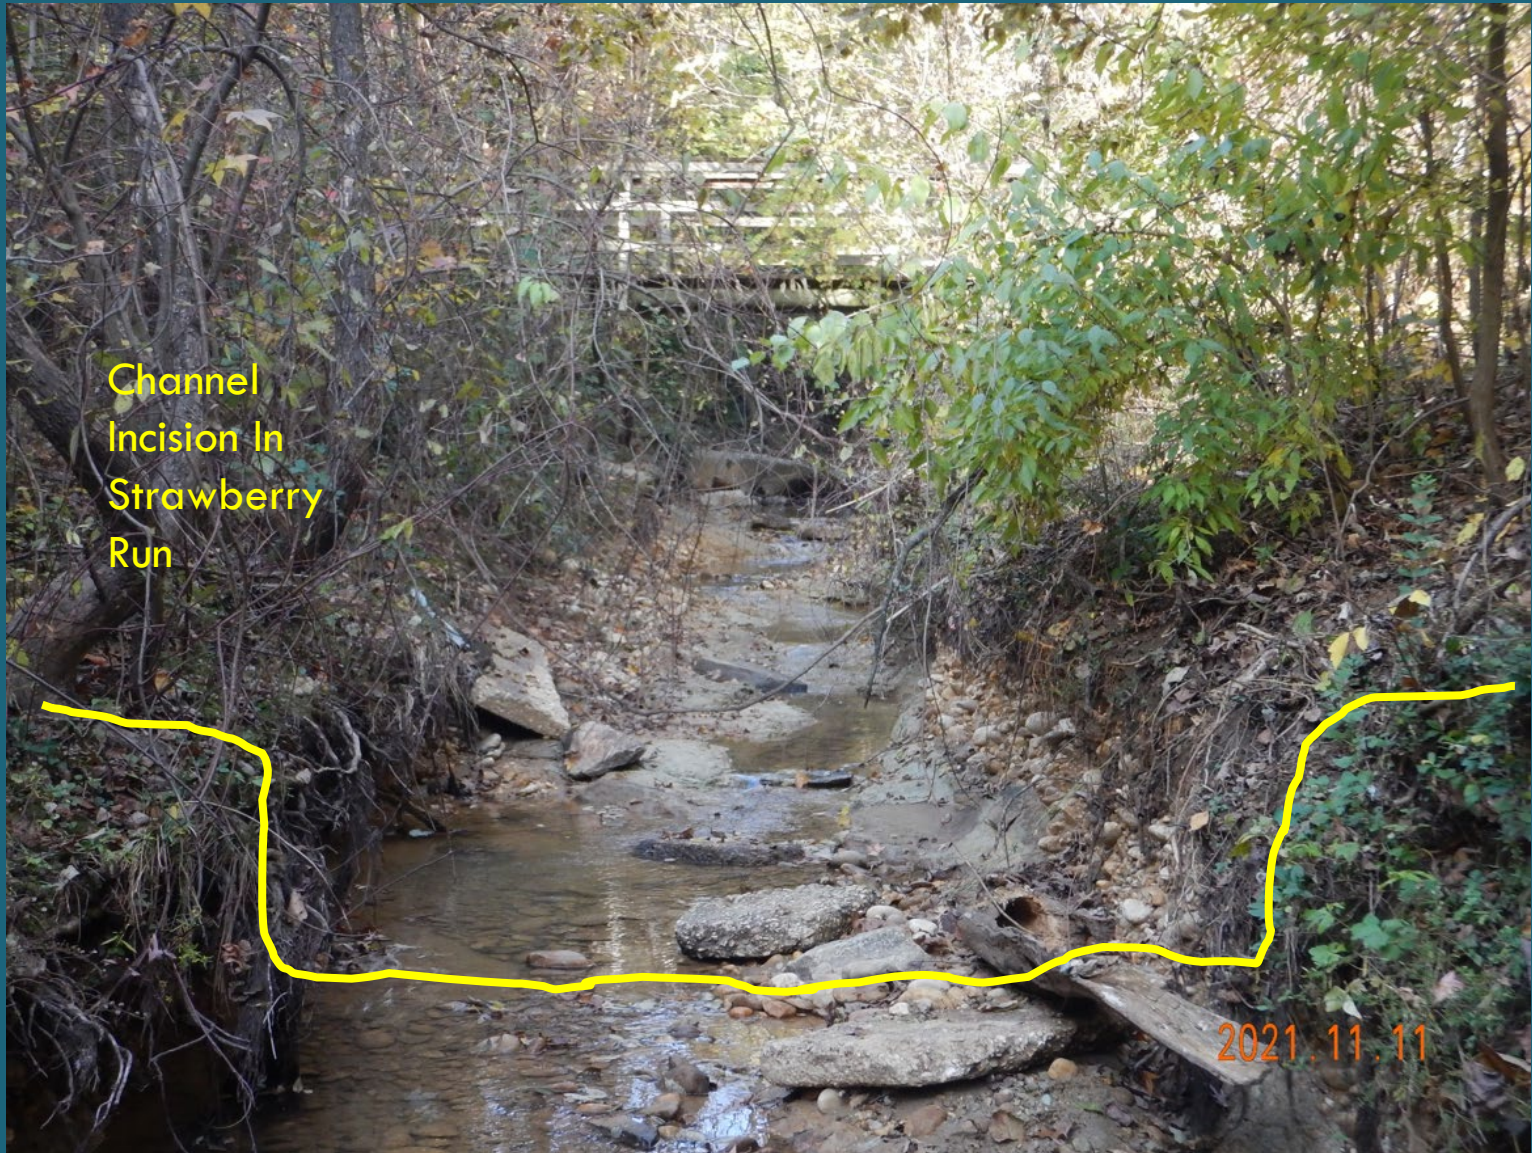
2021.11.11

Channel
Incision In
Strawberry
Run

11/11/21 (Looking upstream towards pedestrian bridge)

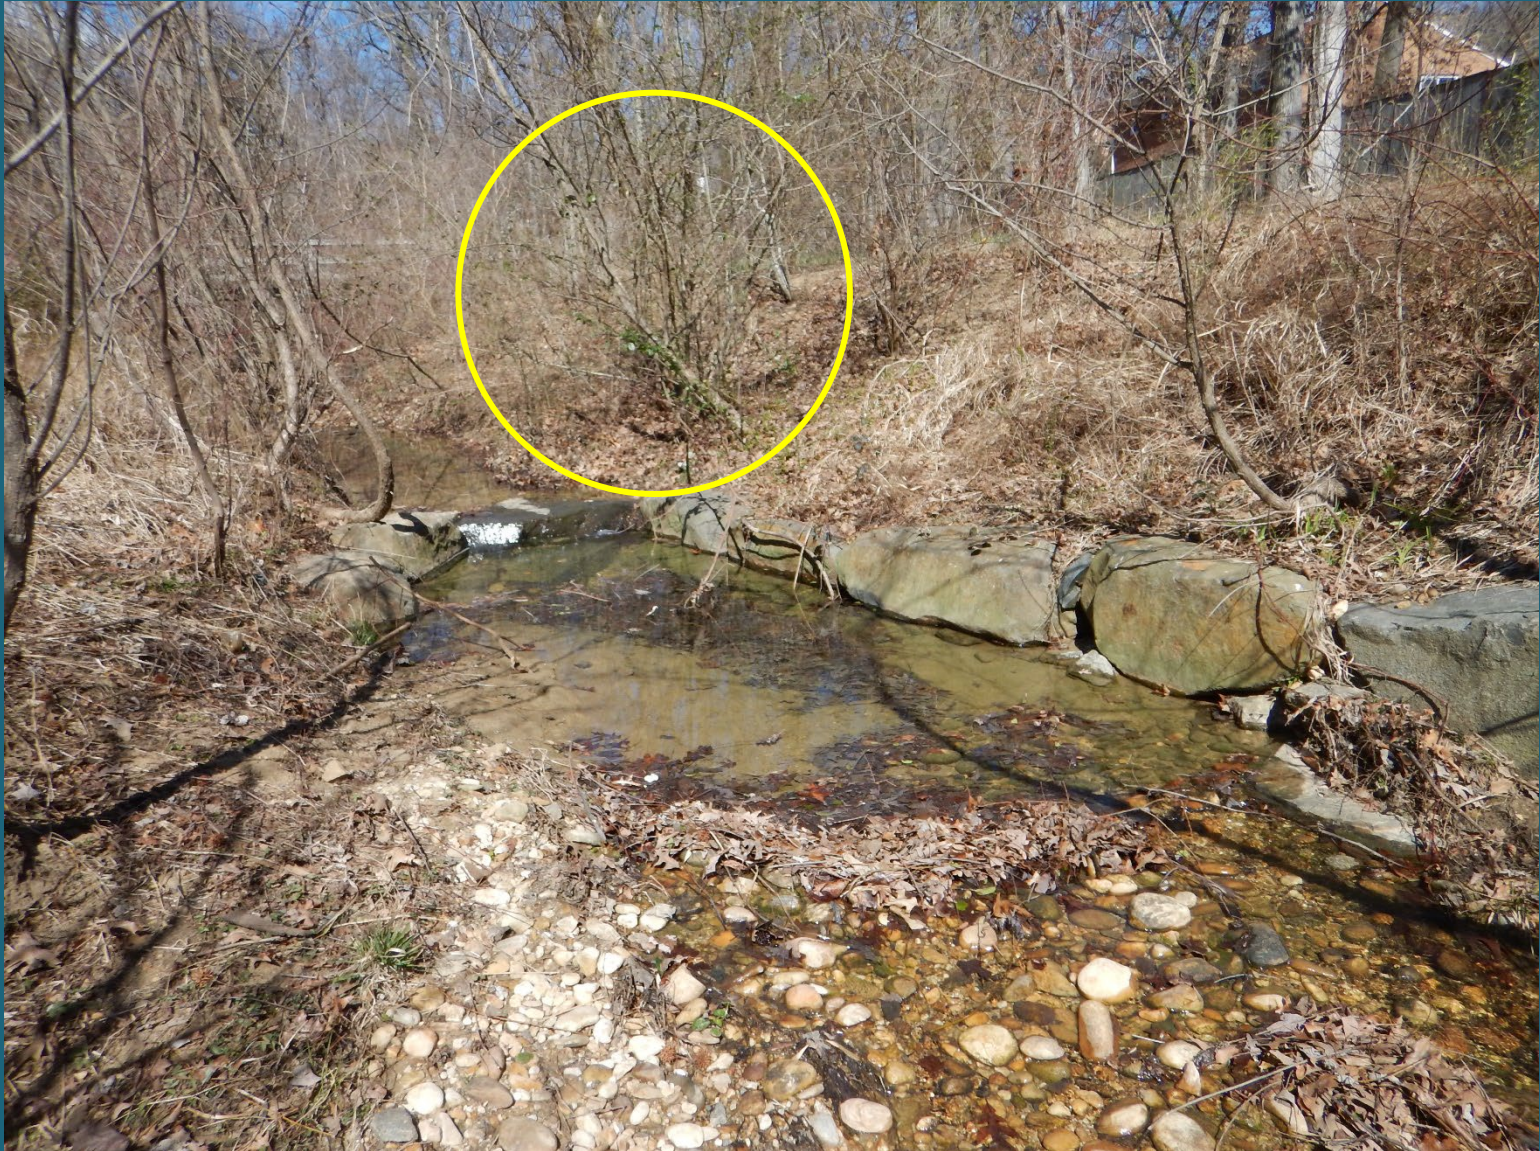
J-Hook #3, March 2018

Follow the tree in the yellow circle

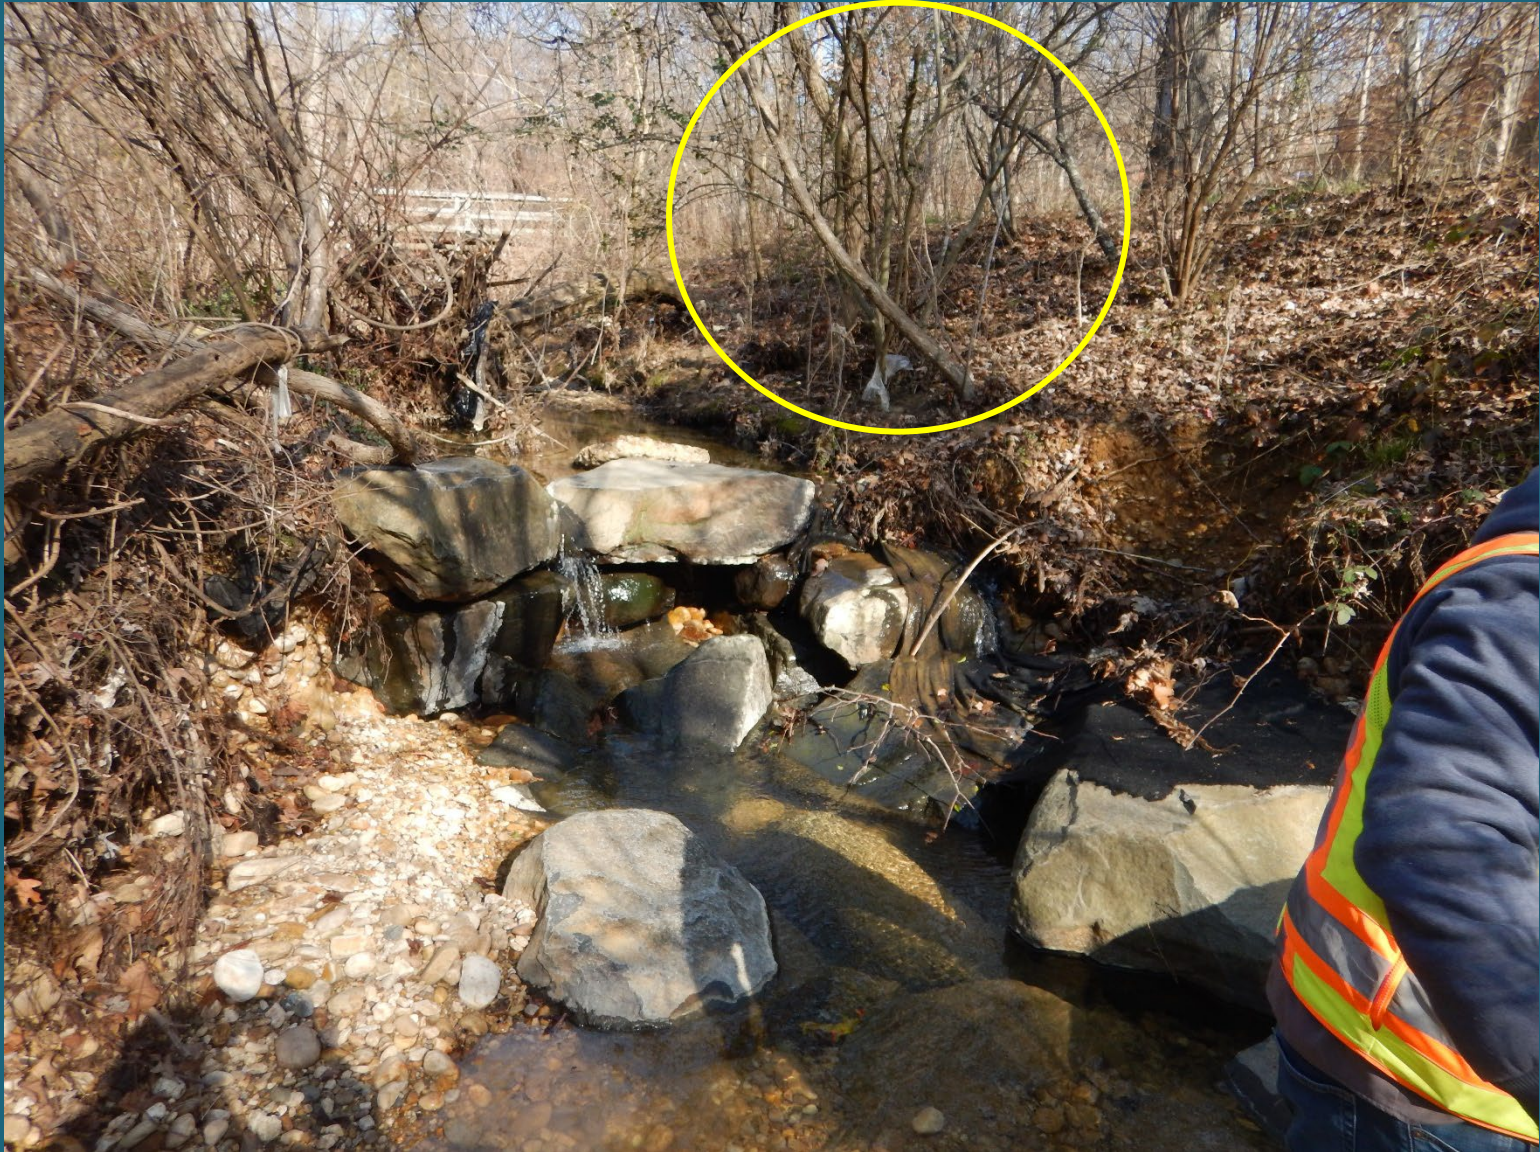
J-Hook #3, January 2021

Follow the tree in the yellow circle

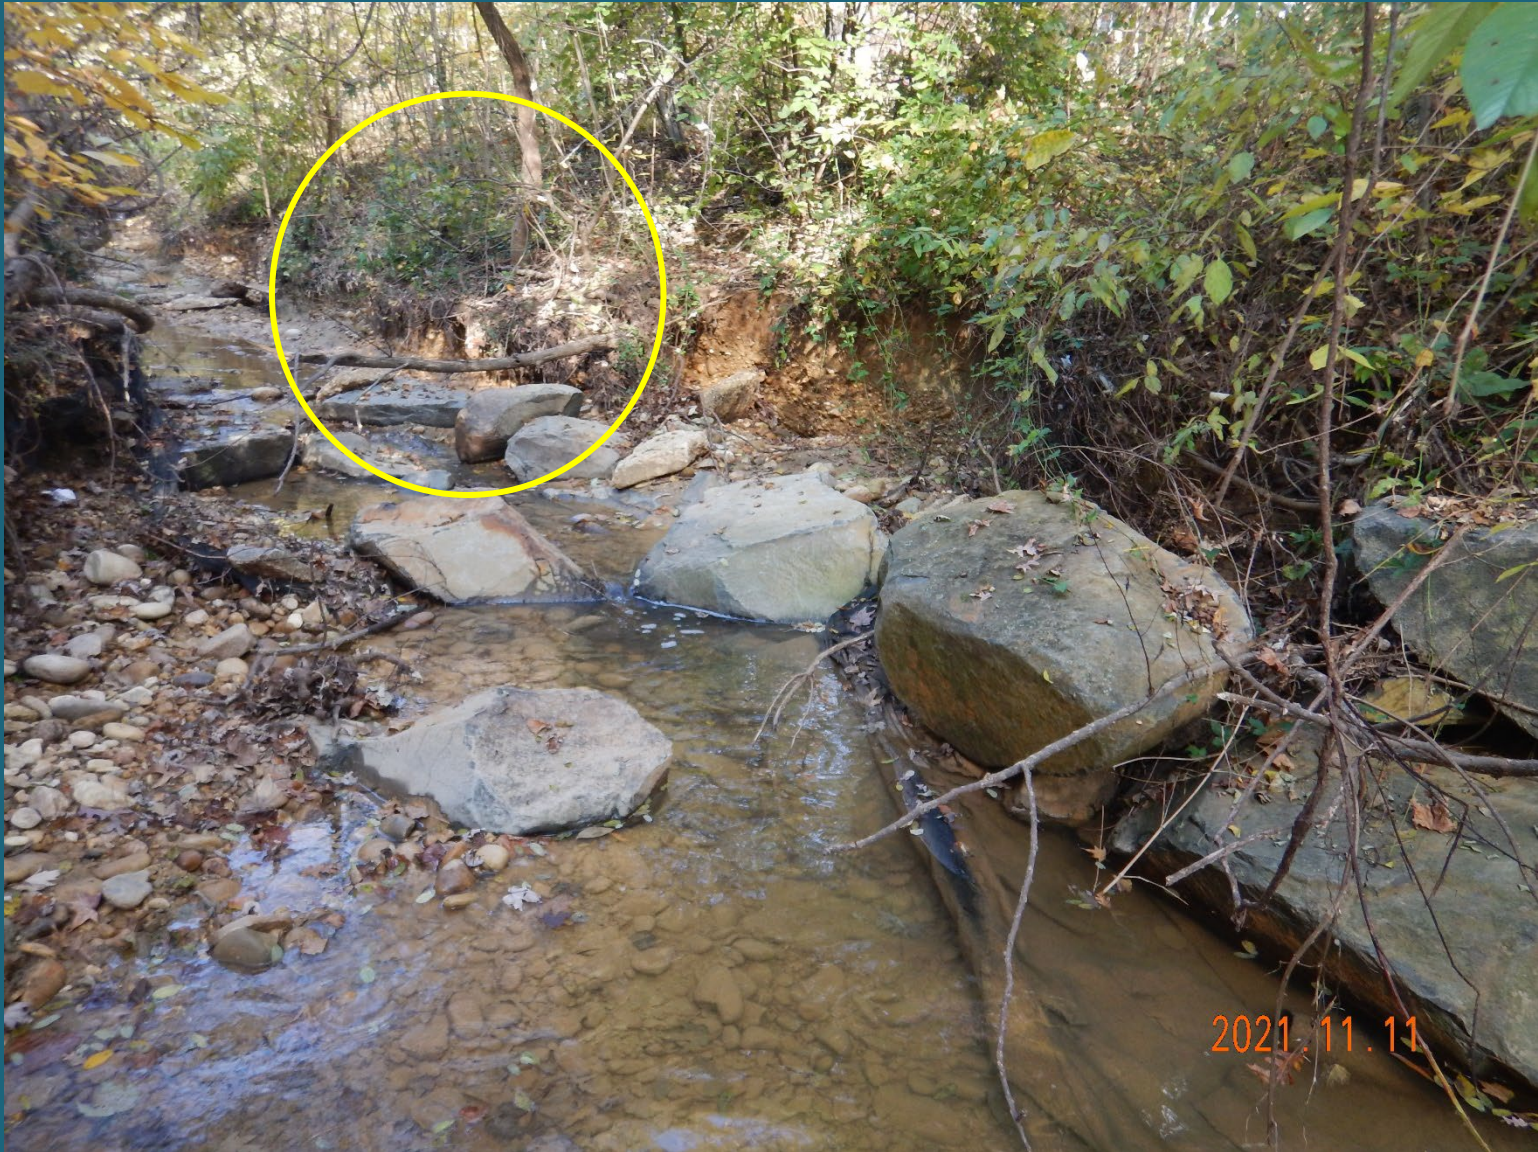
J-Hook #3, November 2021

Follow the tree in the yellow circle

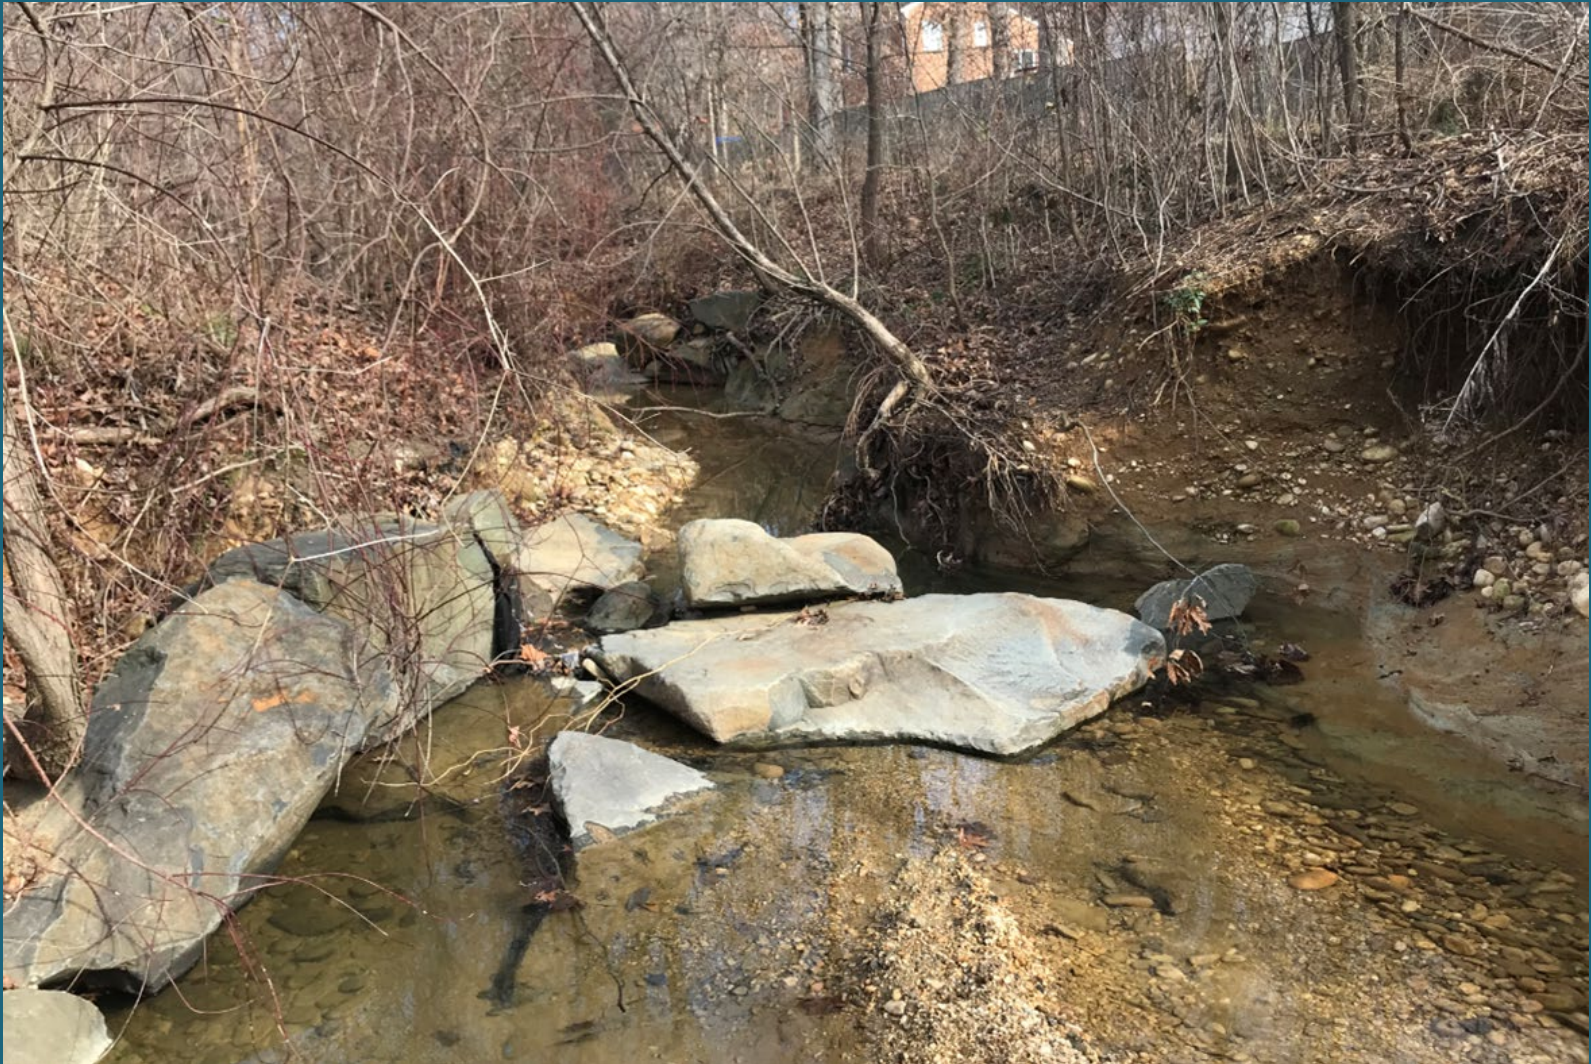
Scour Of J-Hook #2

November 2021; Looking Upstream

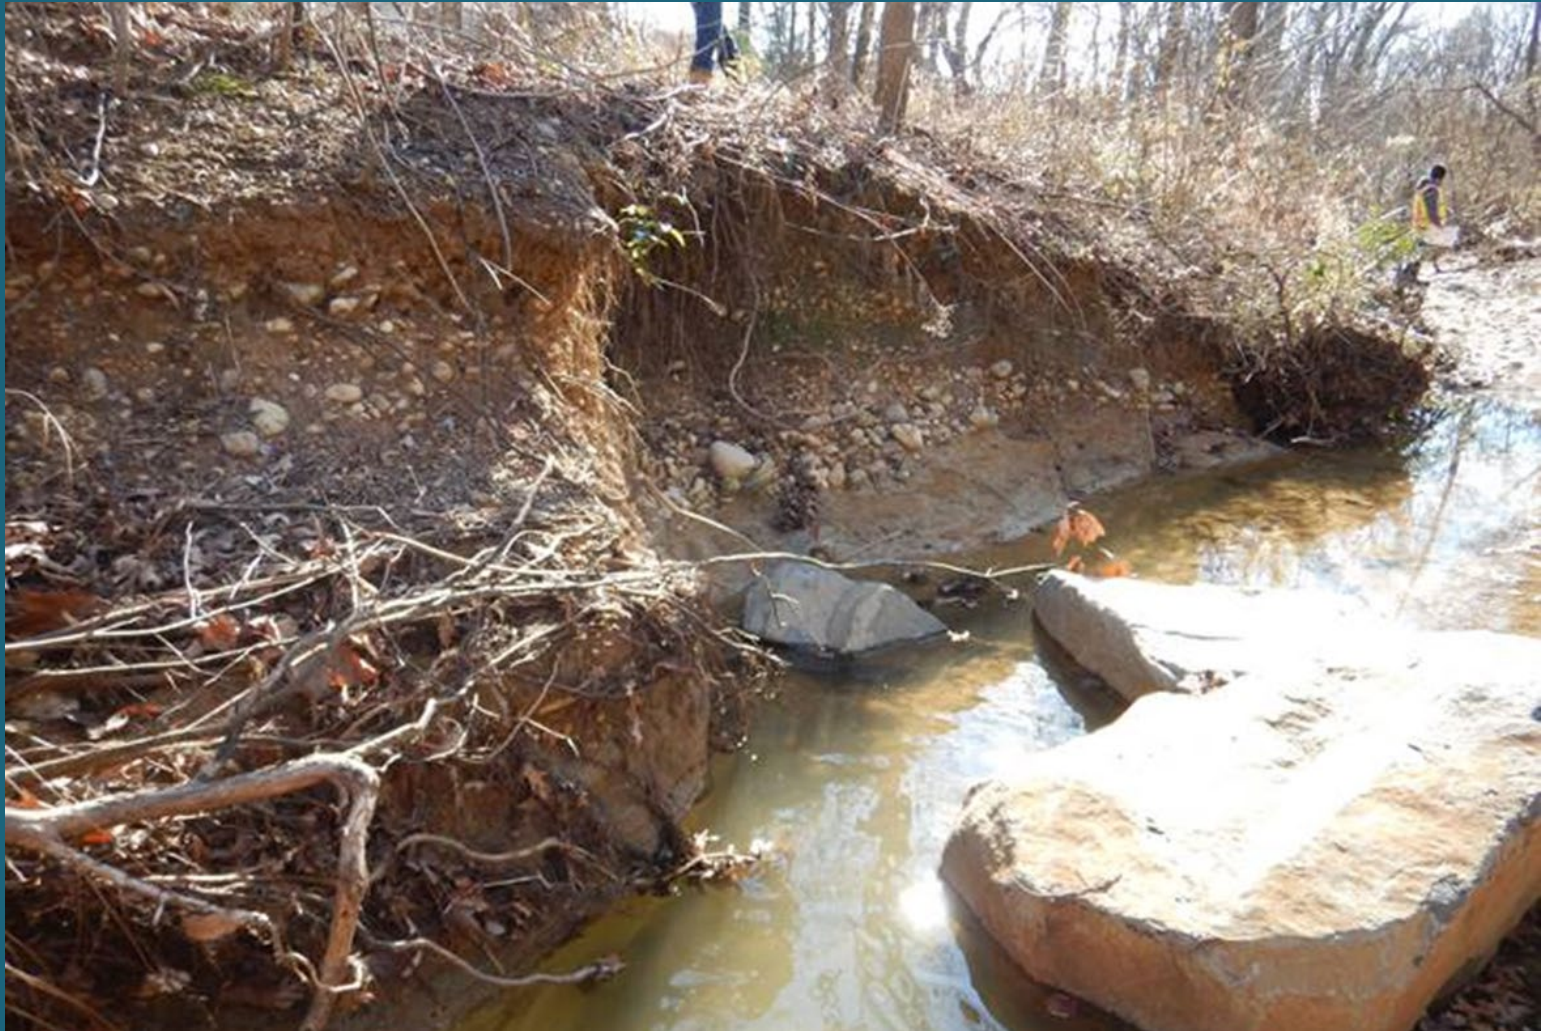
Scour Of J-Hook #2

November 2021; Looking Downstream

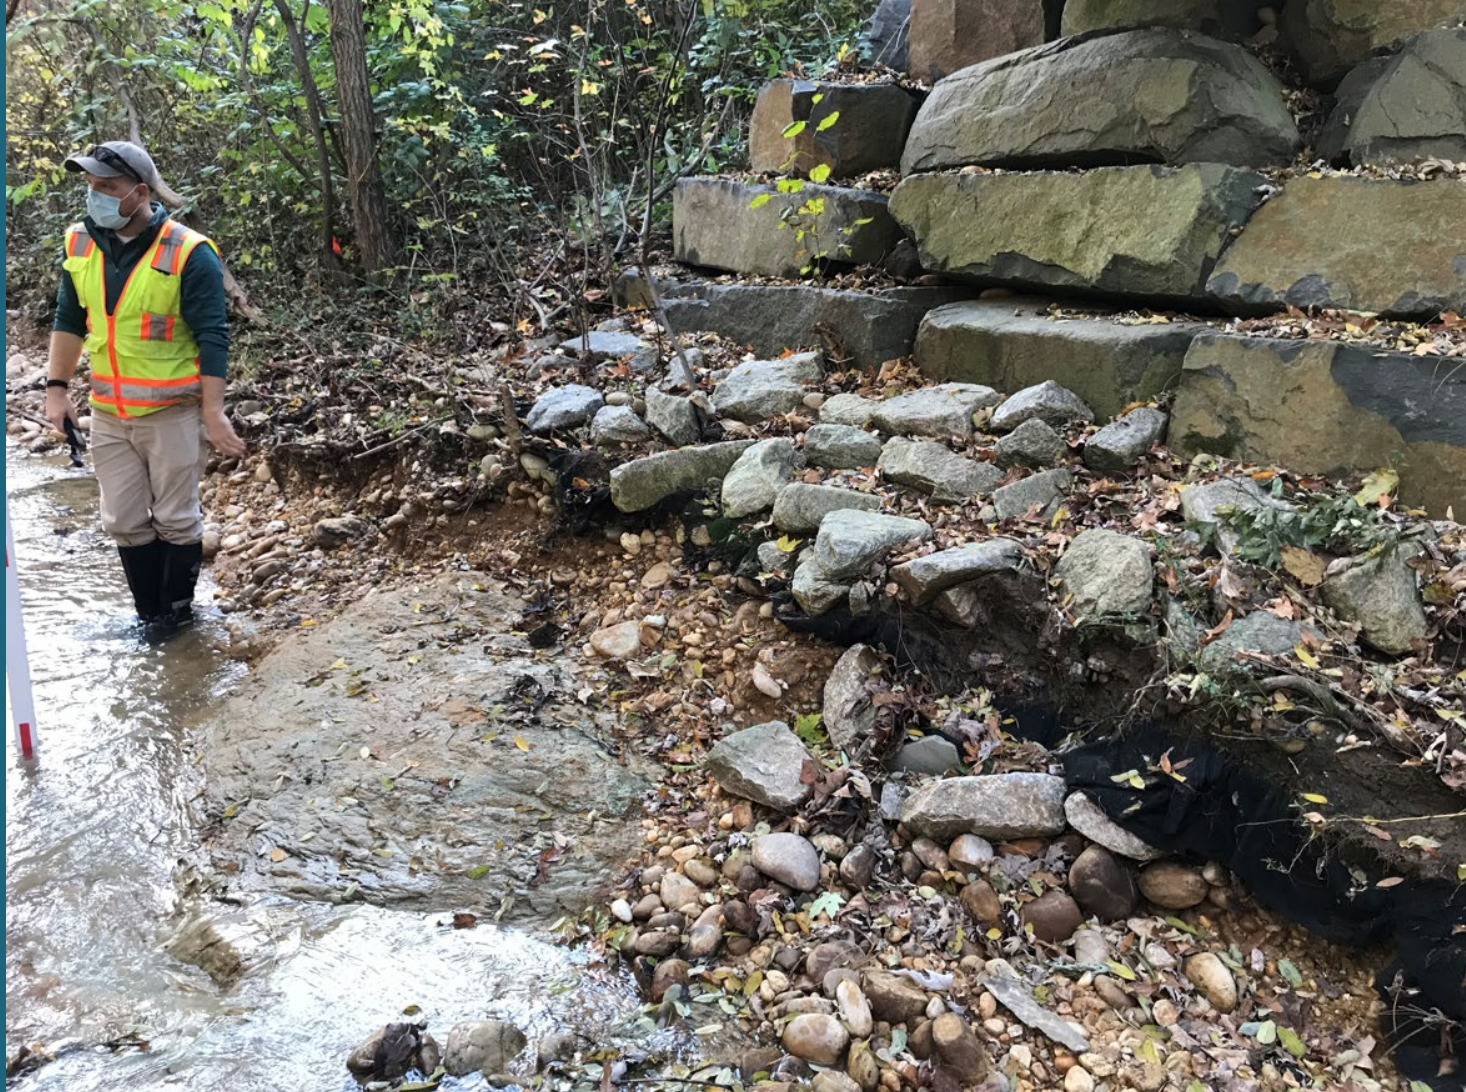
Failure Or Collapse Of Bank Protection Measures

November 2021; Underneath Pedestrian Bridge

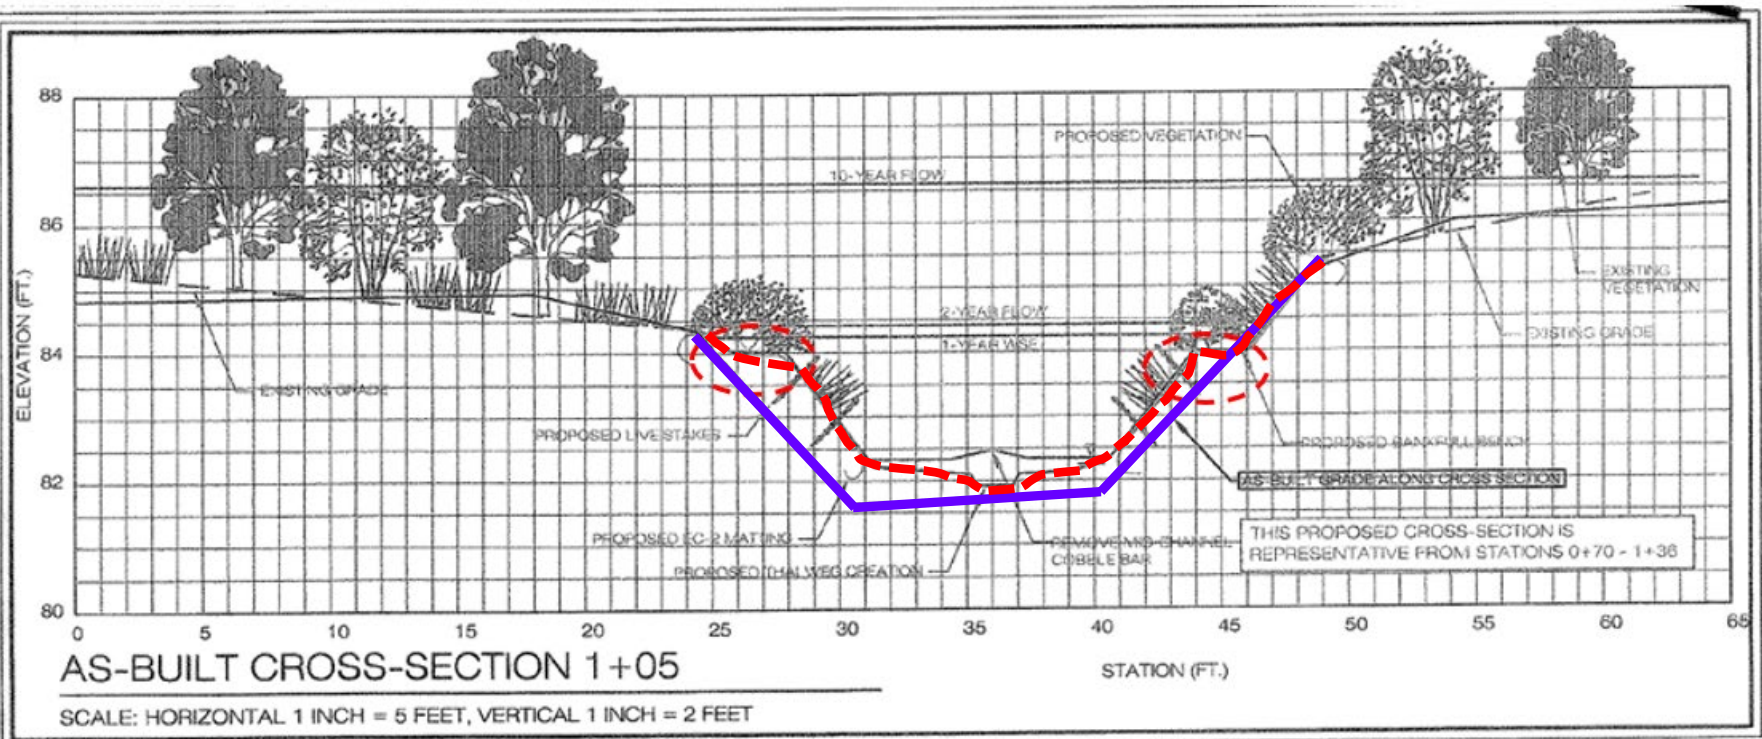
Construction As-built

- Constructed channel elevations not matching the design profile (structure elevations too high)
- Constructed cross sections not matching the design sections (no bankfull bench)

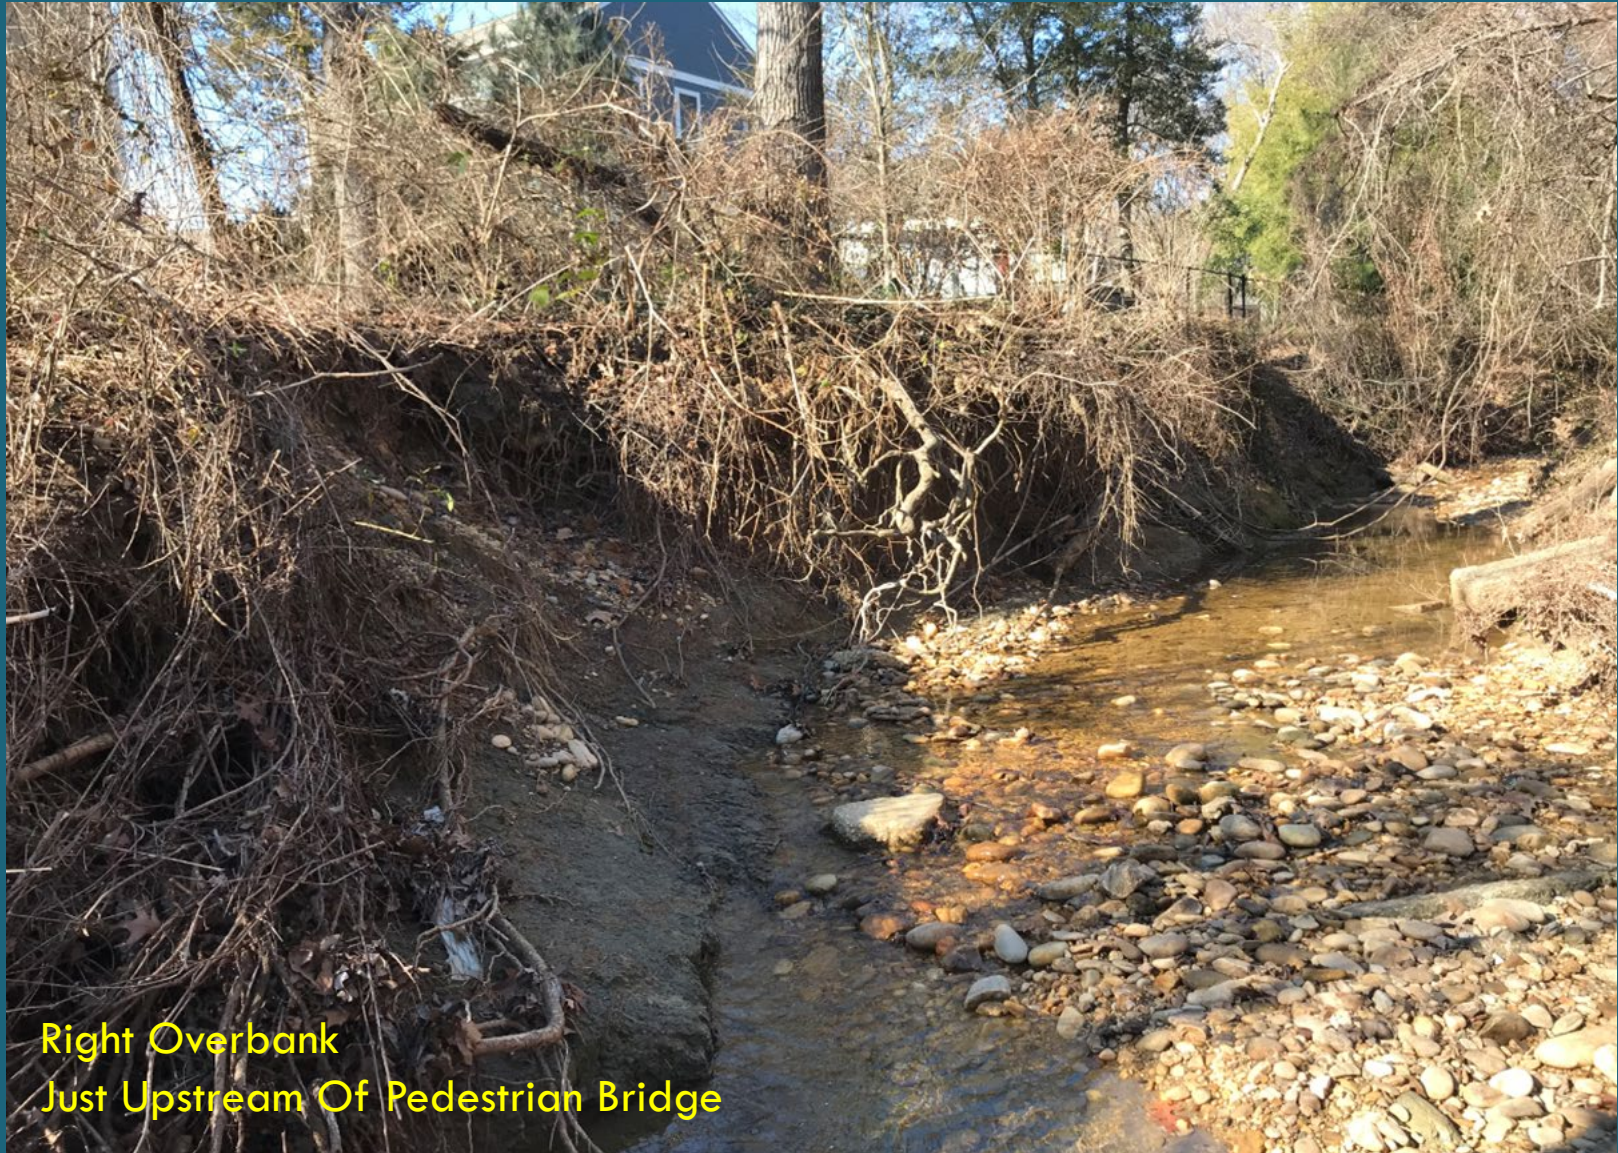
Upstream Bedload Supply

Right Overbank
Just Upstream Of Pedestrian Bridge

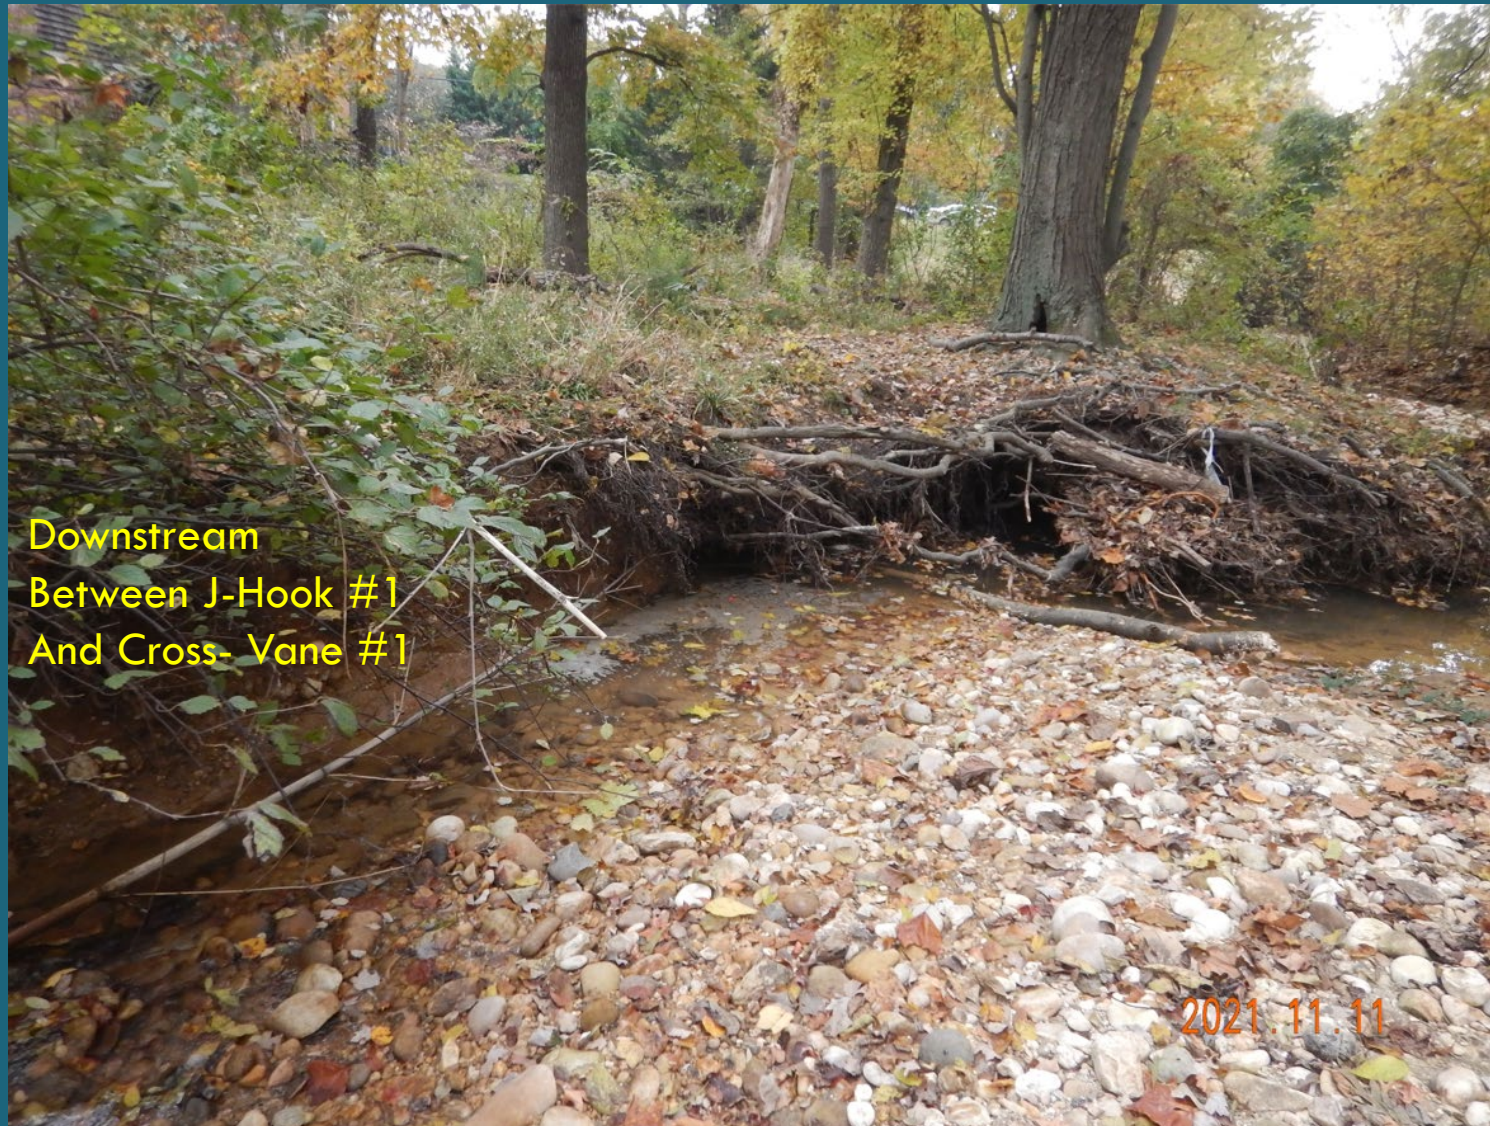
Aggradation

Downstream
Between J-Hook #1
And Cross- Vane #1

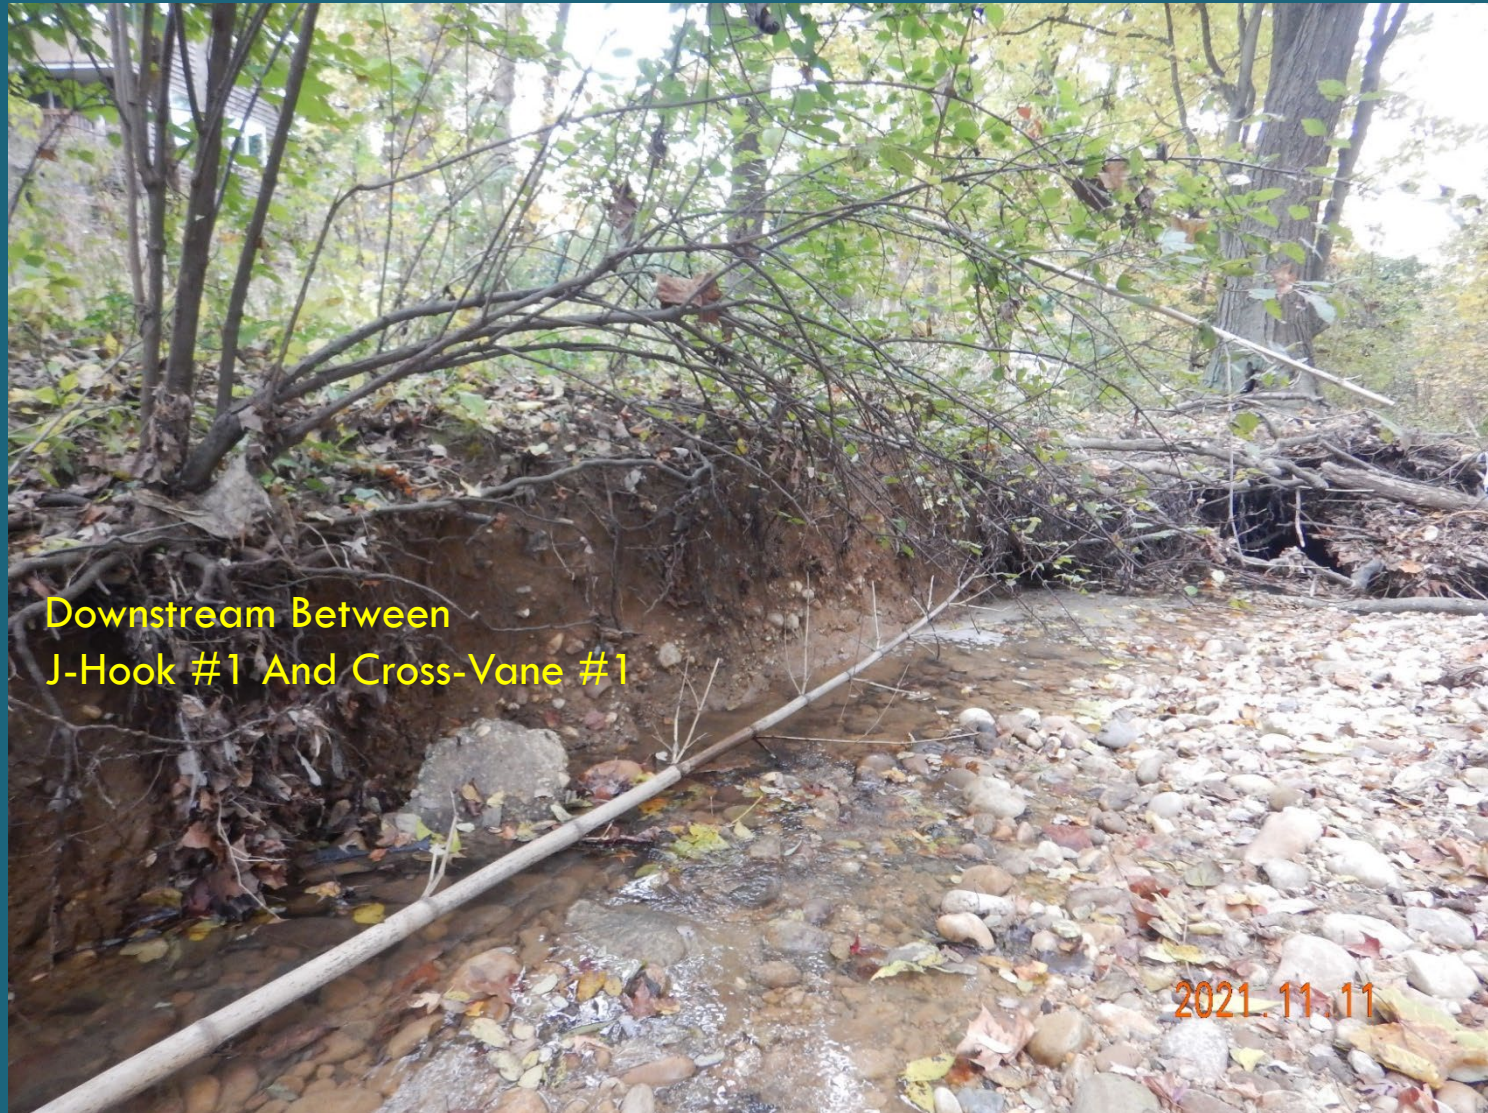
Lack Of Rock Toe Protection

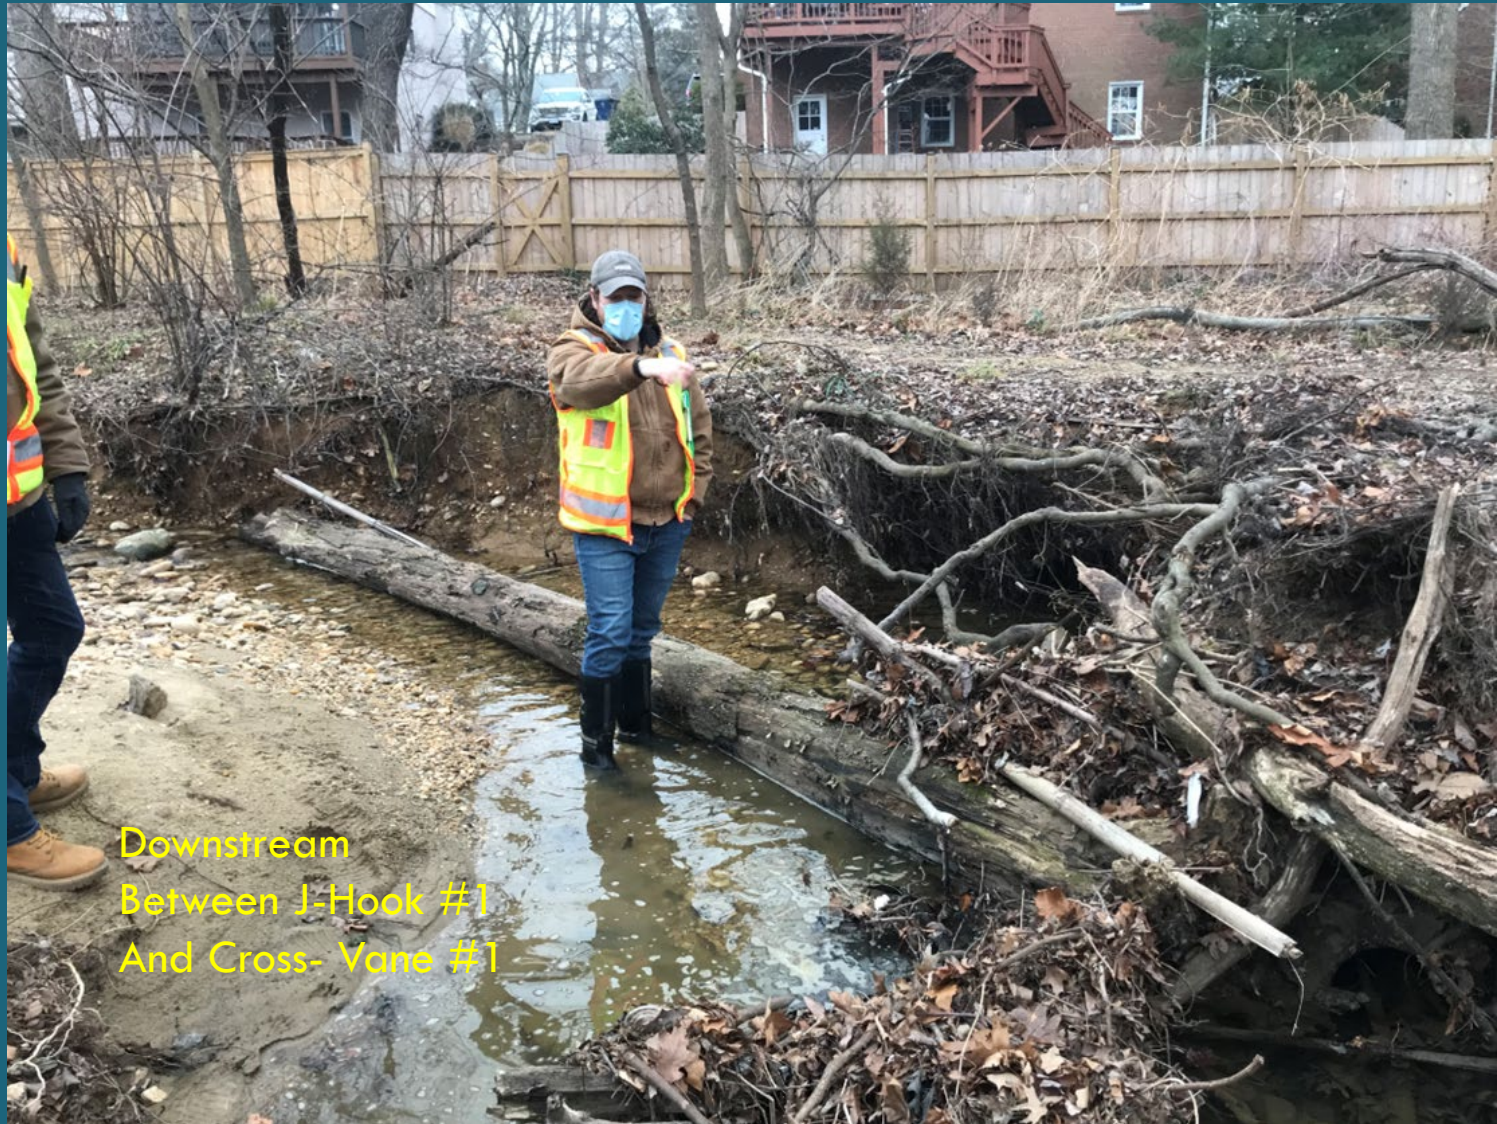
Downed Trees / Channel Blockages

Downstream
Between J-Hook #1
And Cross- Vane #1
