# Strawberry Run Stream Restoration

Ft. Williams Park

Transportation and Environmental Services, Office of Environmental  
Quality

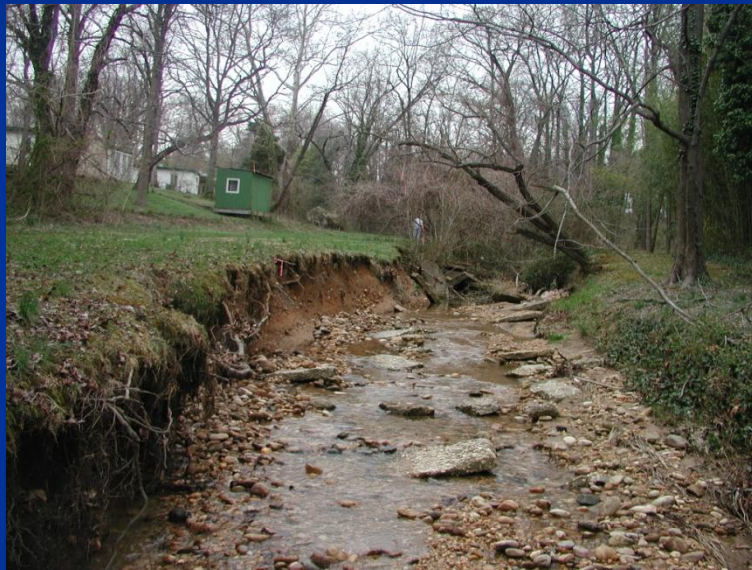
2005

Strawberry Run suffers from high velocities as evidenced by the down-cutting creating the vertical side banks and depressed stream bed. There is also a considerable amount of concrete and other debris in the stream that serves to negatively deflect flows creating erosive forces.

Looking upstream toward the bridge

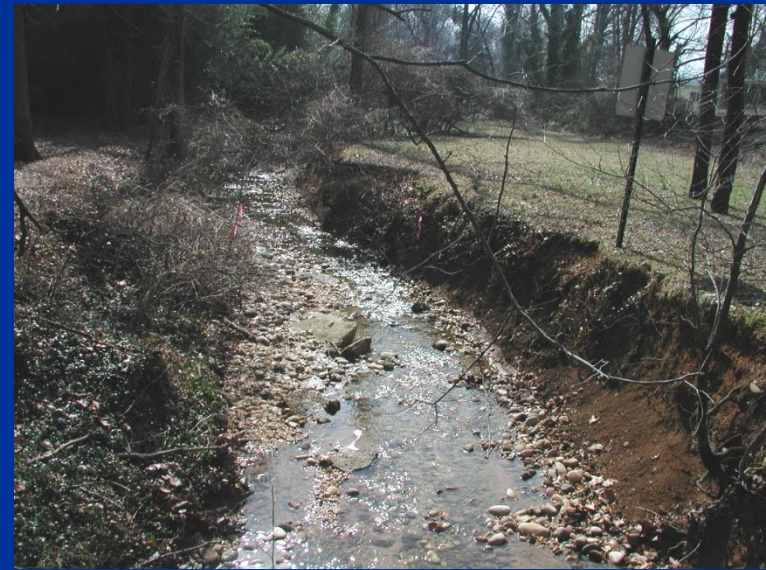
2004

Looking downstream from the bridge

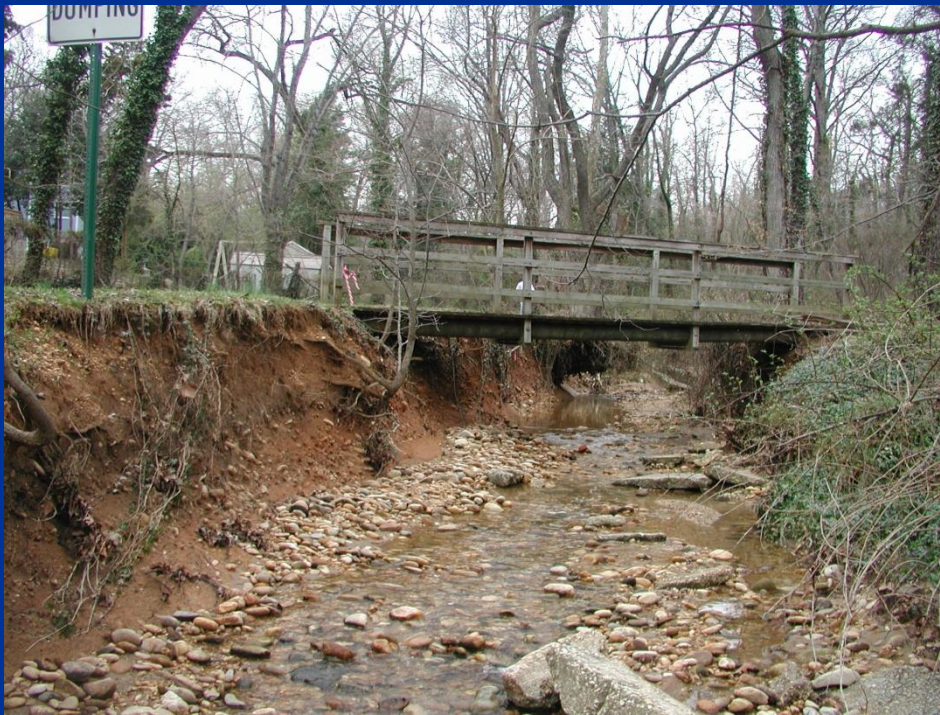
The bridge worked to pinch off the stream. The banks eroded and the stability of the bridge was threatened. While it doesn't look spectacular in this picture, it was decided that this bridge could be a signature piece in the restoration.

Looking upstream toward bridge (2005)

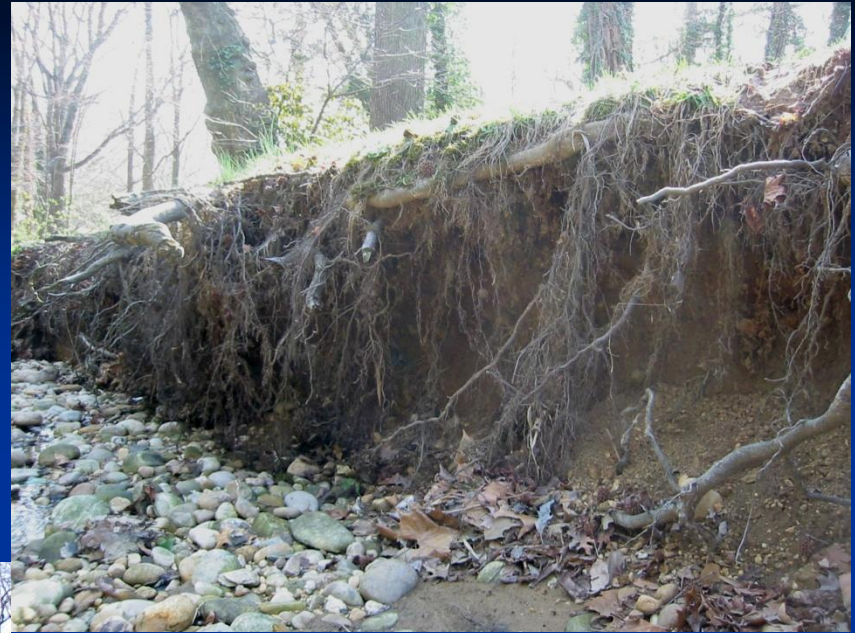
This is another example of the erosive forces of water undercutting the vegetation that usually anchors the stream bank in place. What is left is dangling roots.

Here you see some examples of invasive species that need to be removed. Note the Bamboo and English Ivy climbing the trees. Ivy will eventually kill this tree and the bamboo competes with other native plants (trees and bushes) that would otherwise provide habitat for riparian animals and birds.

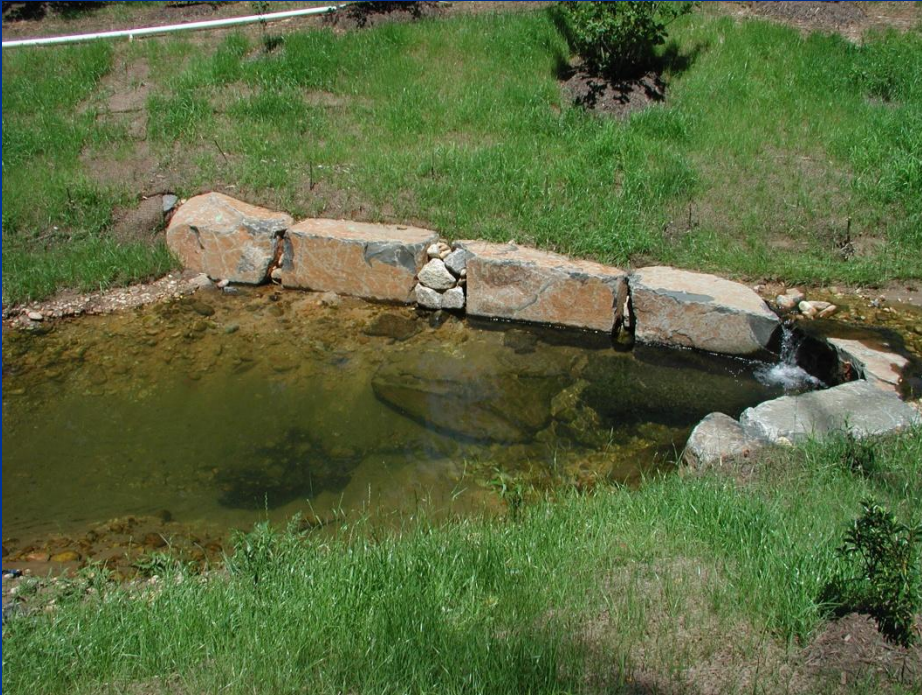
The Virginia Stream Restoration & Stabilization Best Management Practices Guide  
 DETAIL 4.2(a): J-HOOK VANES

# J-Hook

\* Designer to Provided Offset and Elevation for Points A,B,C

Seal All Structures per Fig. 3.2 For Streams with a Sand portion in the bed.

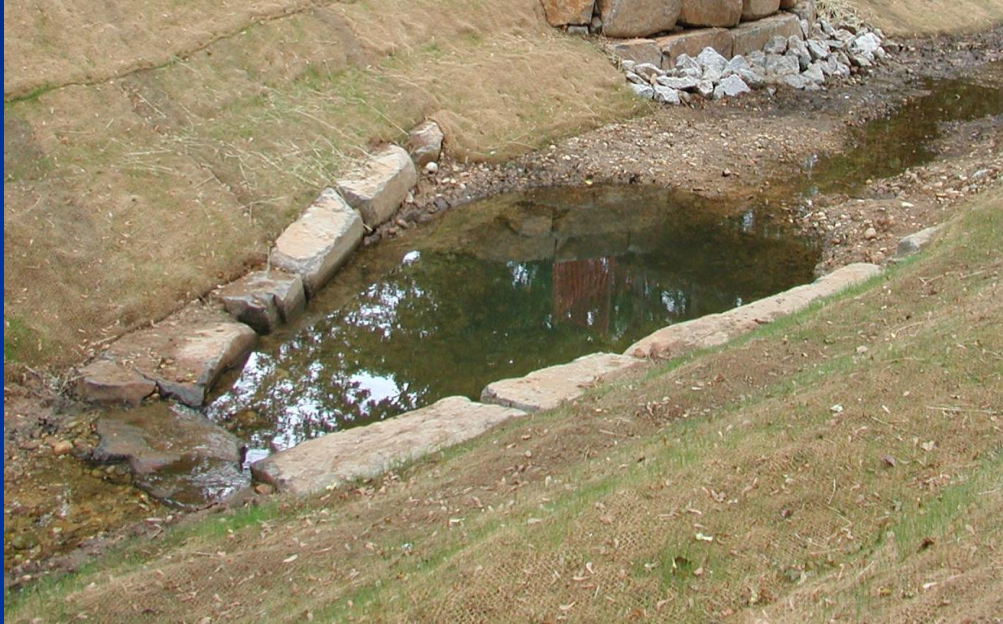
## The Virginia Stream Restoration & Stabilization Best Management Practices Guide DETAIL 3.1(a): ROCK CROSS VANES

# Cross Vane

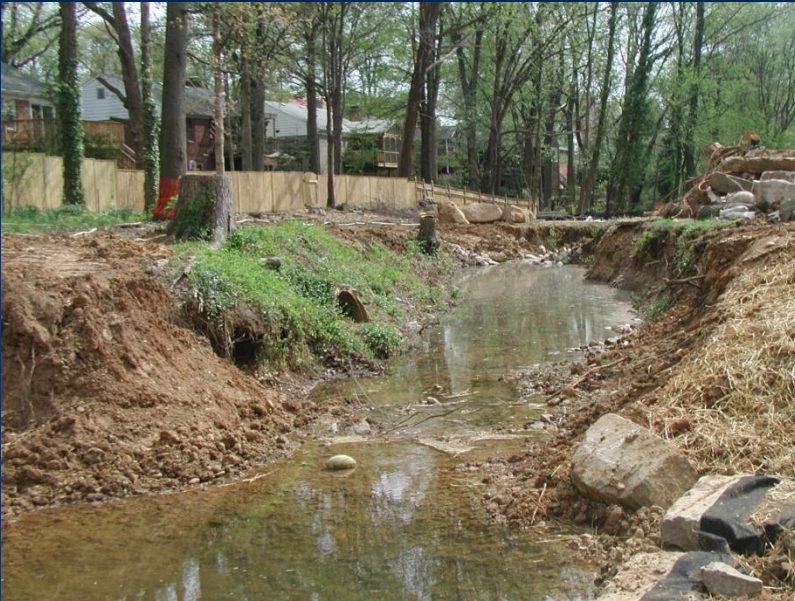
Looking Downstream

Bridge removed, trees cut and pulled, vegetation scraped.

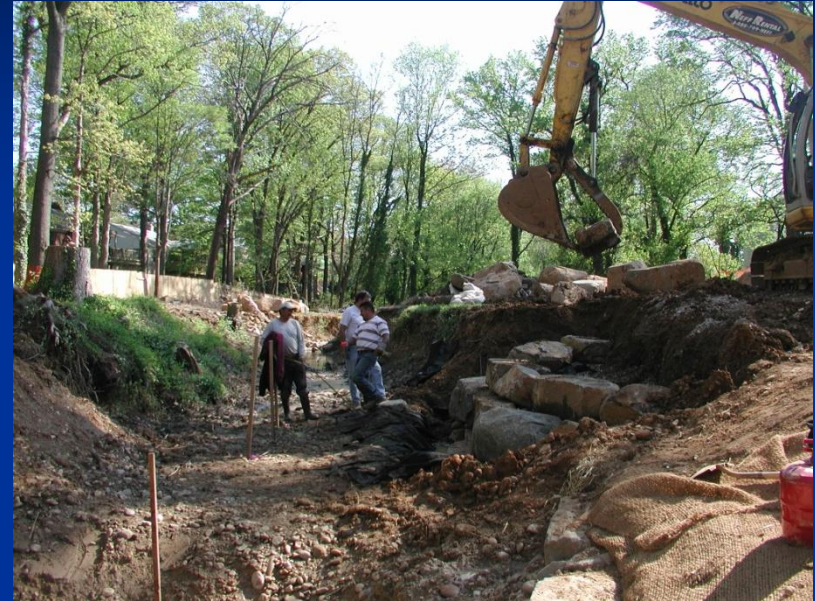
Looking Downstream

Footers in place. Adding more boulders.

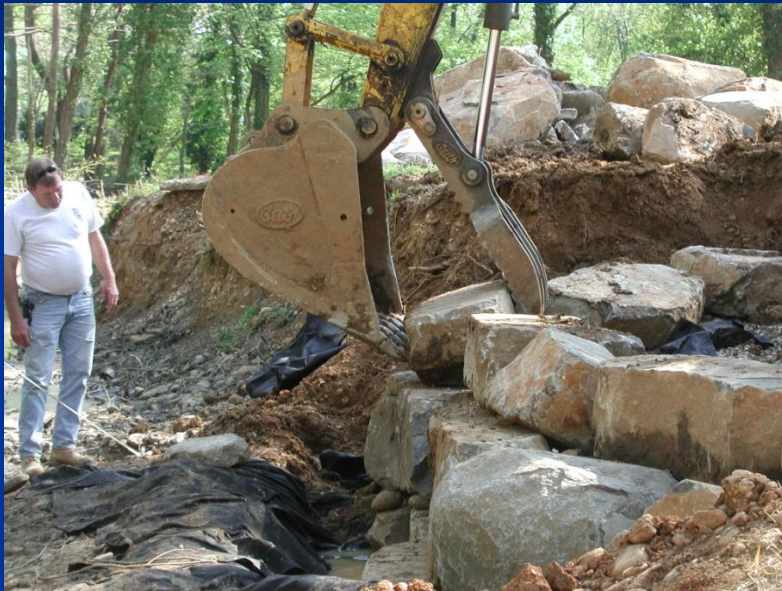
The art of setting the boulders in just the right location and elevation.

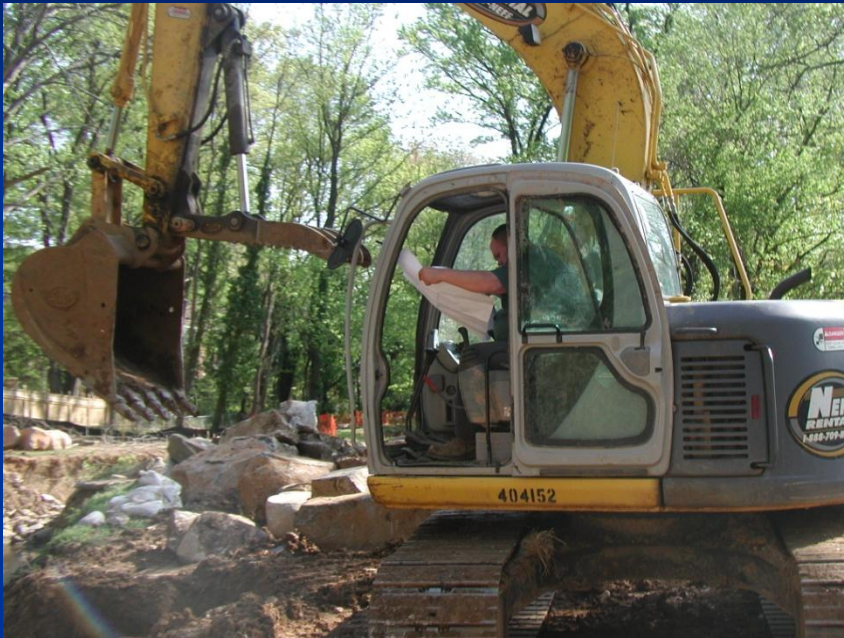
Check the plan one more time.

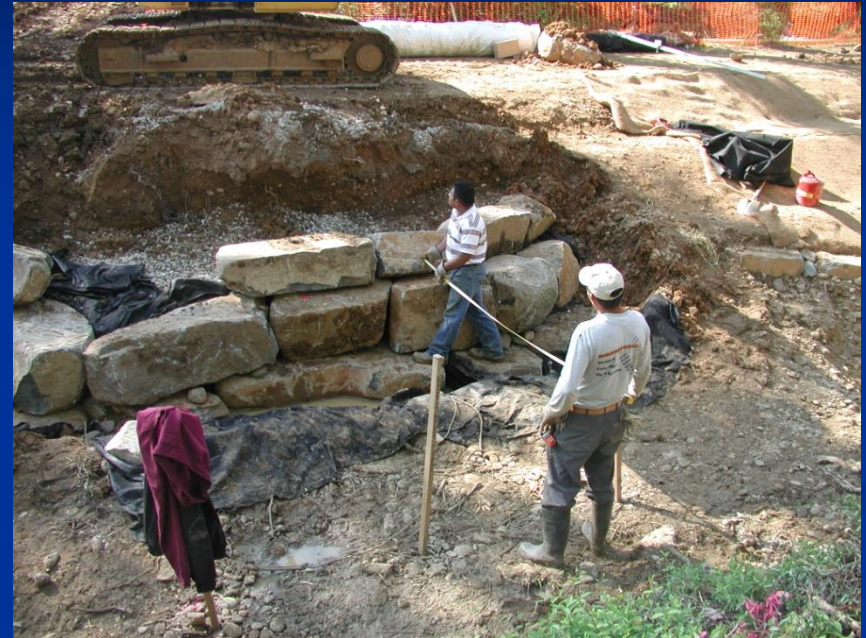
Checking centerline and elevations

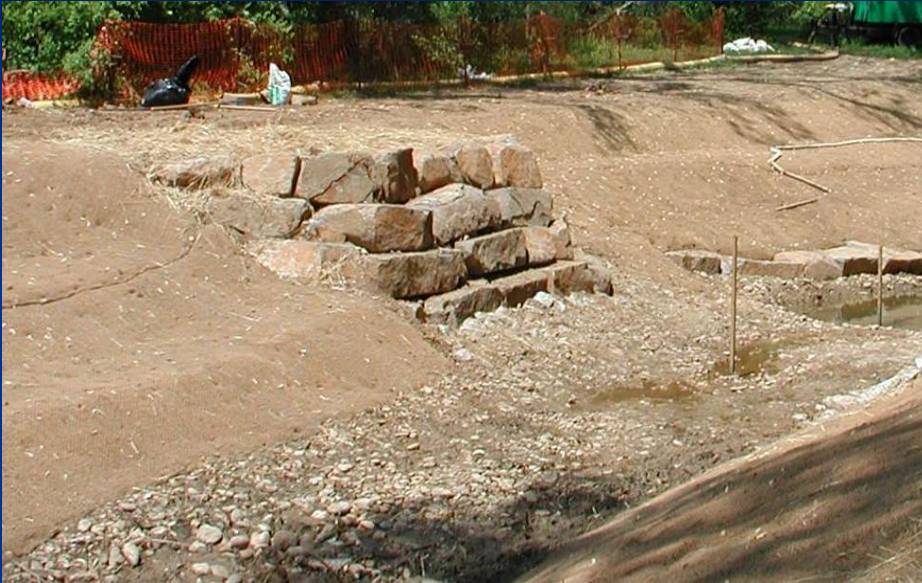
Left bank looking upstream

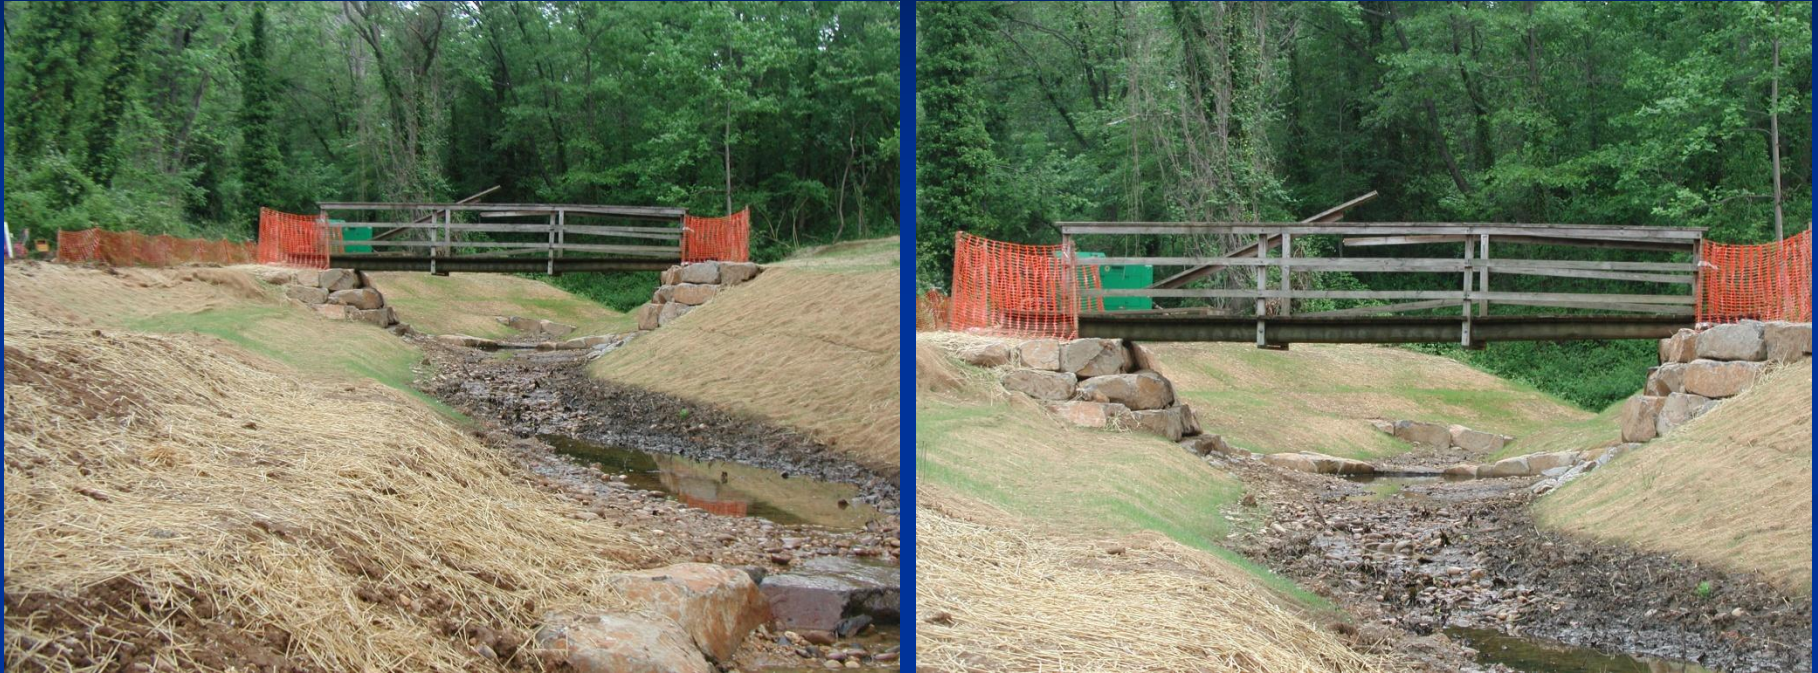
Bridge just needs a few repairs. You try lifting a bridge in one piece and not breaking anything.

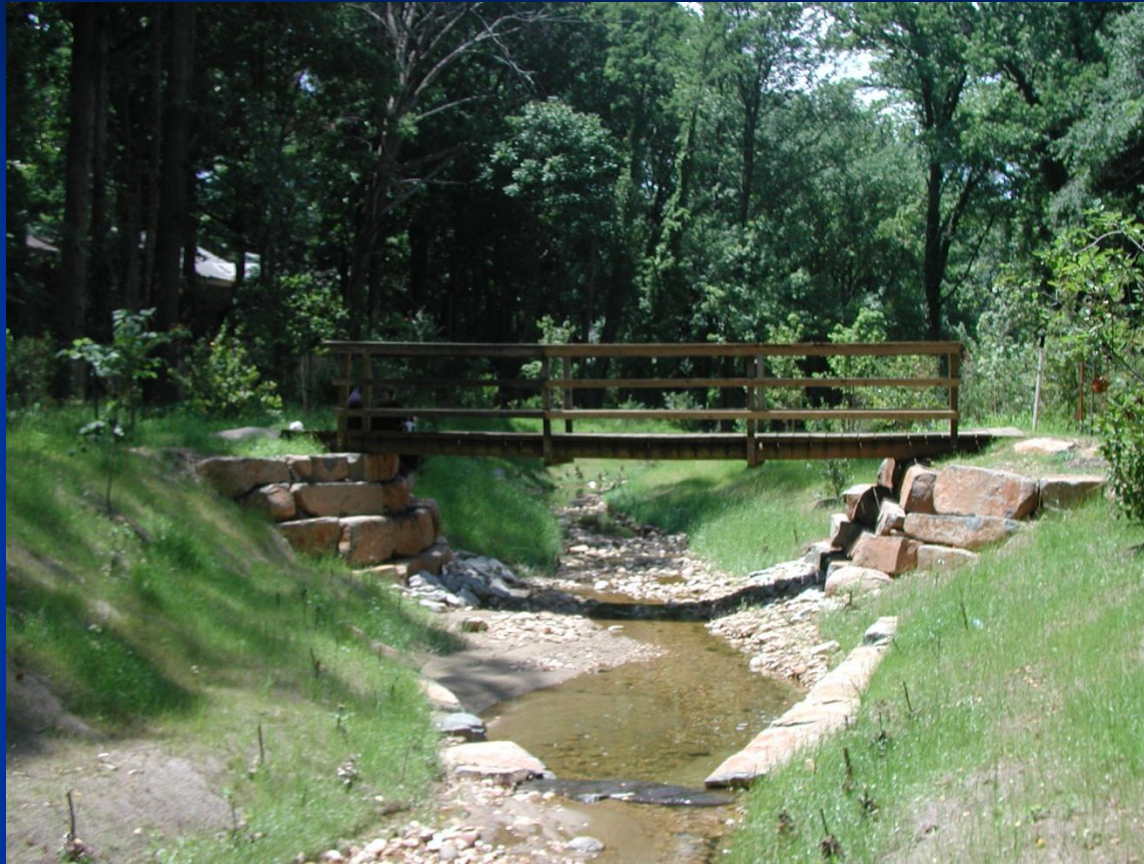
Looking downstream after bridge rails were repaired, grasses begin to grow, after landscaping and the placement of the live stakes (willows).
