# Strawberry Run Stream Restoration Project

October 28, 2020  
Virtual Public Engagement Meeting

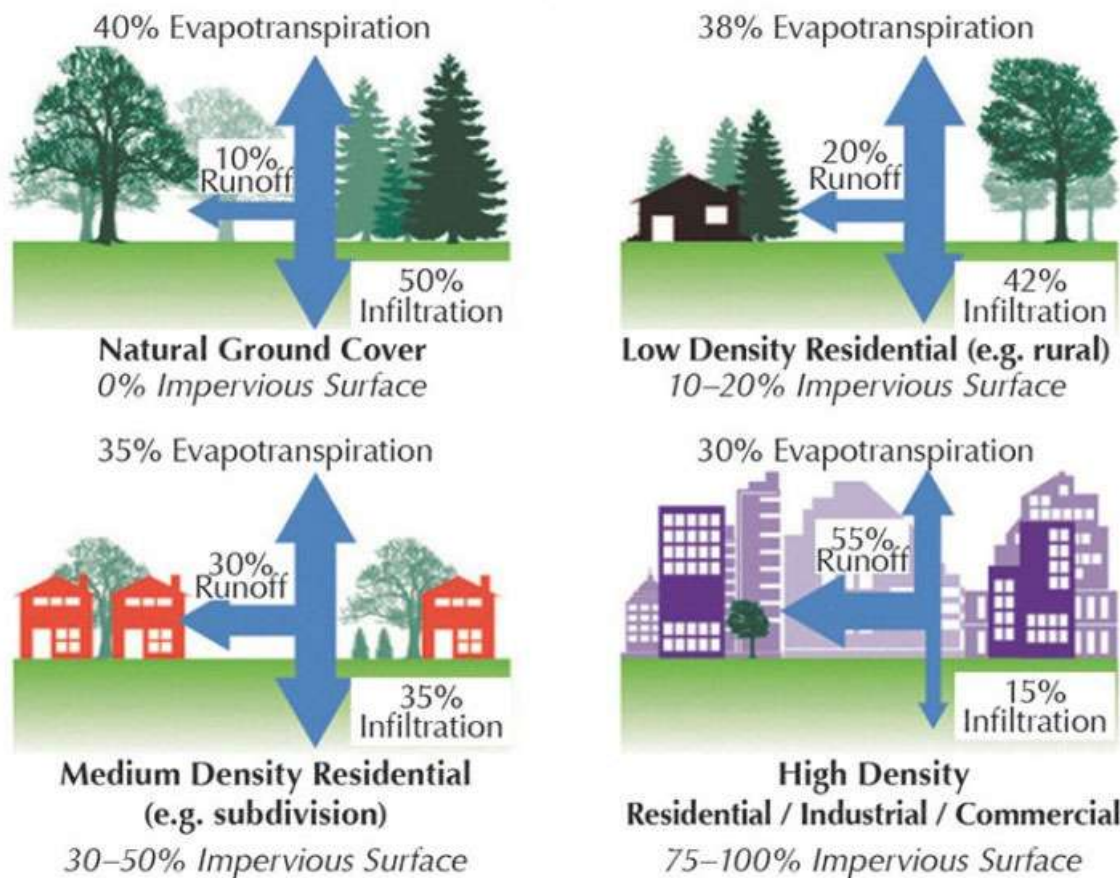
## EFFECTS OF IMPERVIOUSNESS ON RUNOFF AND INFILTRATION

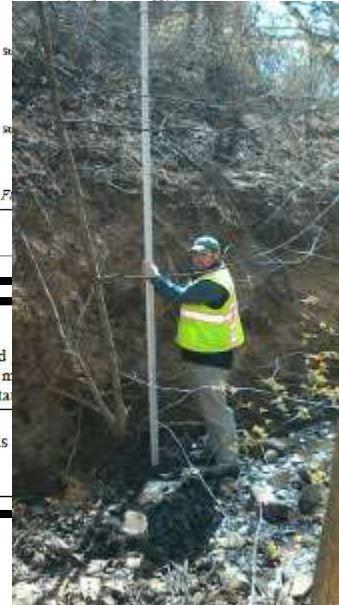
Stage I: Stable channel initial incision bed.

Stage II: Bed degrading banks stable.

Stage III: Bed aggrading banks unstable.

(1) <b>Good:</b> Stage I or V of Channel Evolution Model	(3) <b>Fair:</b> Stage IV of Channel Evolution Model
--	--

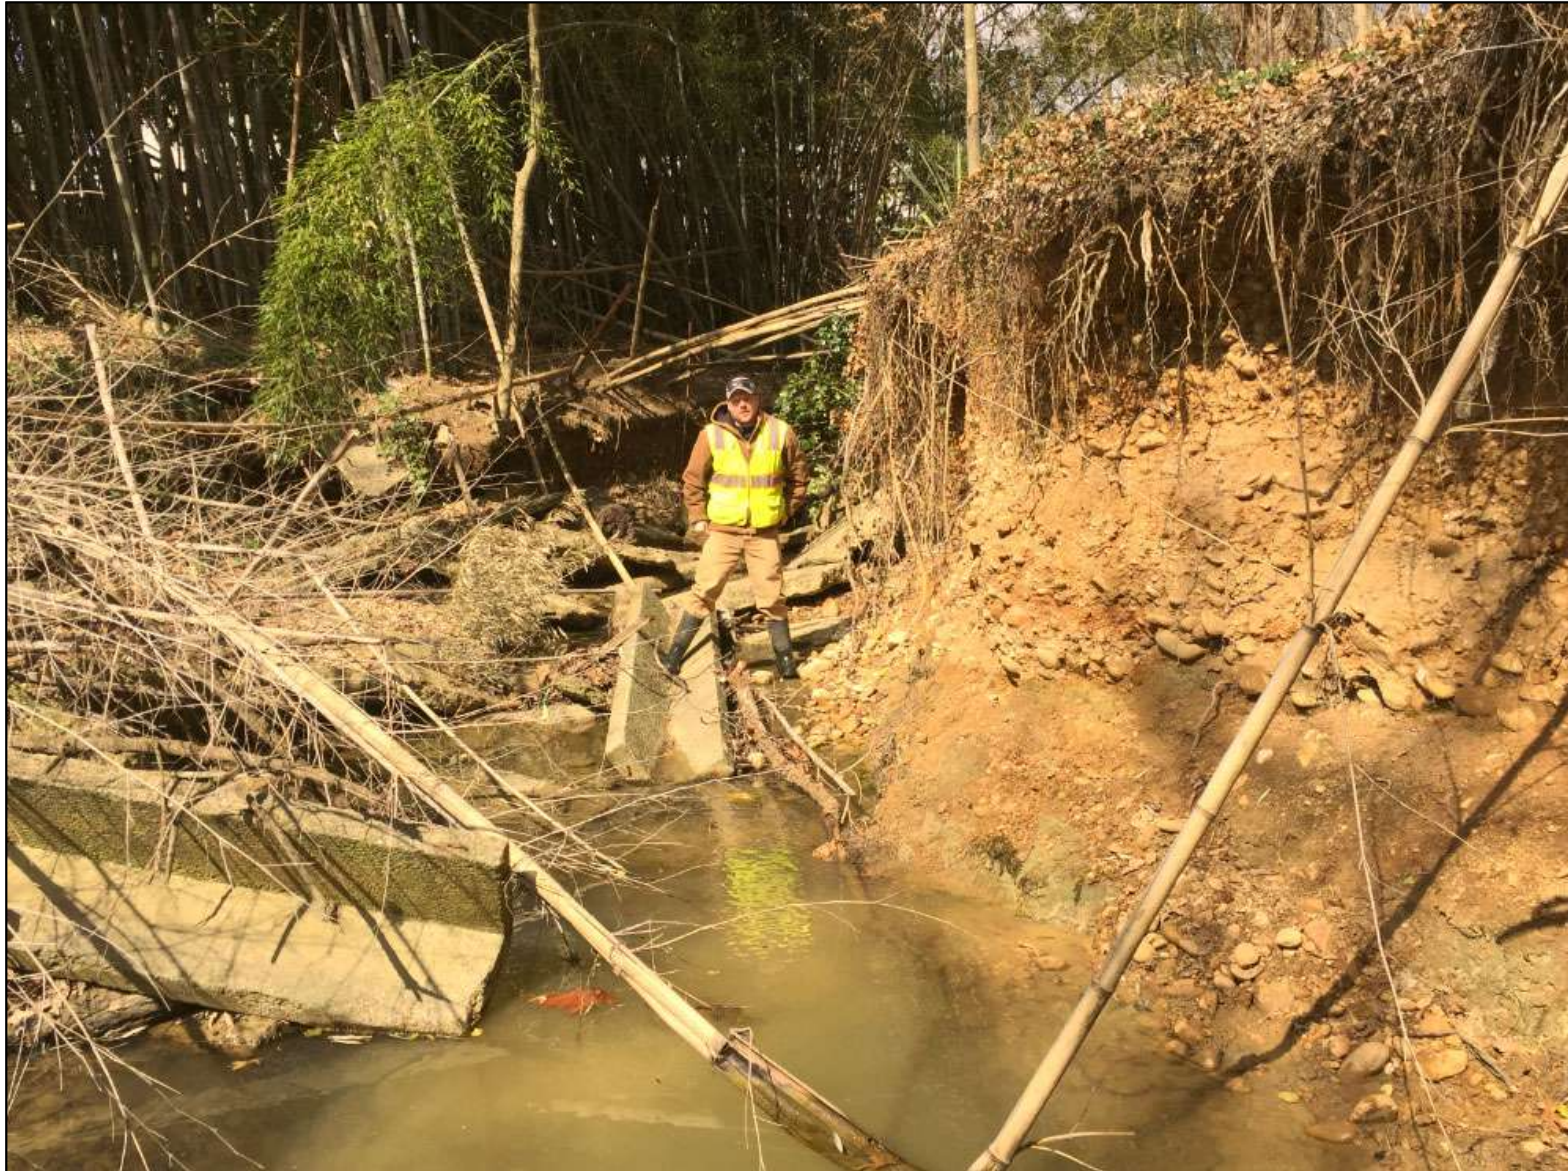
# Bank and Bed Instability

- Heavy stream flows during rainfall events
- Erosion scours stream and undermines trees on banks
- Sediment loss downstream
- Loss of stability
- Stream blockages
- Further bank erosion
- Preventing private property loss
- Protect Infrastructure
- Safety
- Chesapeake Bay TMDL

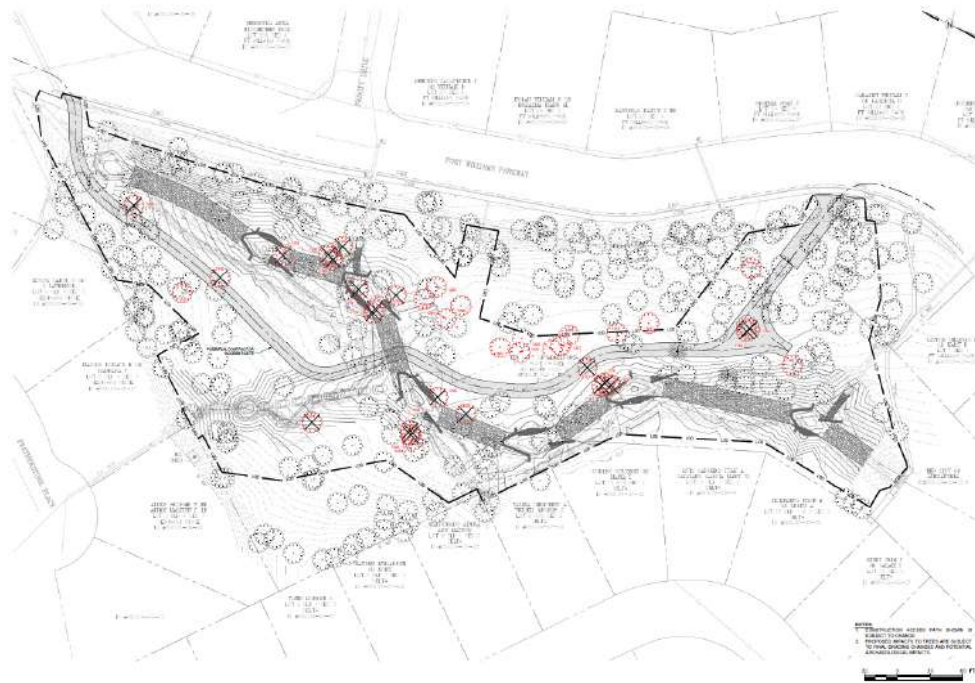
# 1<sup>st</sup> Draft Stream Alignment – Dec 2019

<b>Total Trees Surveyed</b>	<b>353</b>
Trees Removed	206

- Preliminary Tree Removal: 58% of Total Trees Surveyed

<b>Design</b>	<b>Total Trees Surveyed</b>	<b>Trees Removed</b>	<b>Notable Trees Removed</b>	<b>Notable Trees Saved</b>	<b>Percent of Trees Removed</b>
Jan	353	206	34	2	<b>58%</b>
Feb	353	147	22	14	<b>42%</b>
May	353	89	13	23	<b>25%</b>

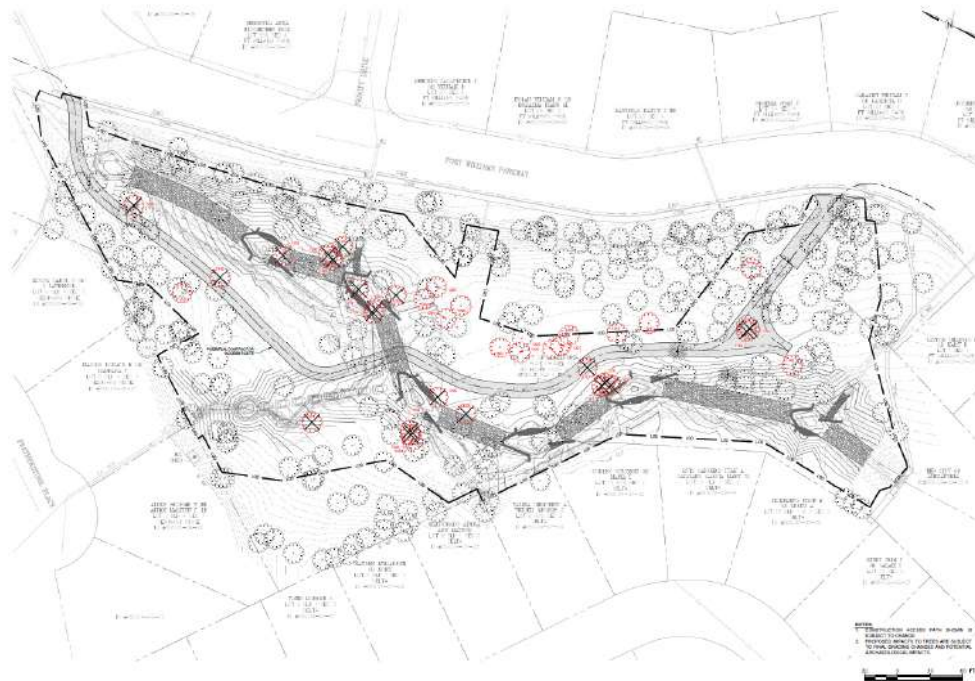
# 1<sup>st</sup> Draft Stream Alignment – Overlay with Notable Trees (Jan)

Total Trees Surveyed	353
Trees Removed	206
Notable Trees Removed	34
Notable Trees Saved	2
Notable Trees Removed Near Top of Bank	8

- Preliminary Tree Removal: 58% of Total Trees Surveyed

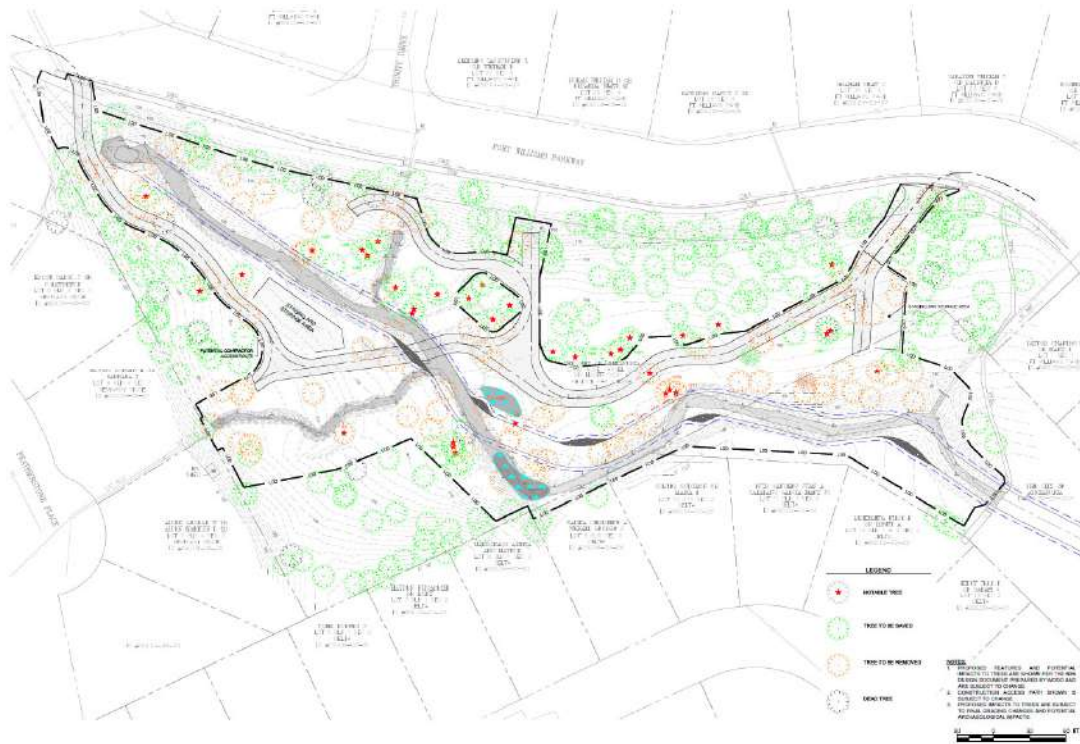
# 2<sup>nd</sup> Draft Stream Alignment (Feb)

<b>Total Trees Surveyed</b>	<b>353</b>
Trees Removed	147
Notable Trees Removed	22
Notable Trees Saved	14
Notable Trees Removed Near Top of Bank	8

- 2<sup>nd</sup> Draft Tree Removal: 42% of Total Trees Surveyed

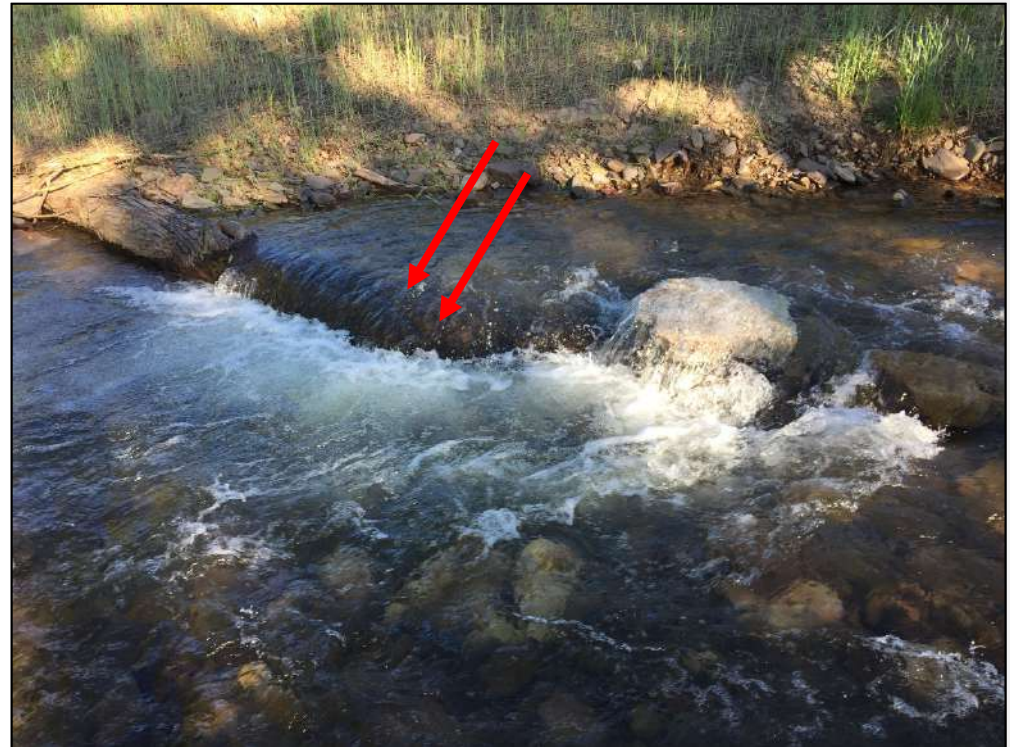
Toe Wood

Cascade with Log Rollers

Log Vane Structure
