Strawberry Run Downstream Forensic Investigation

JUNE 27, 2022

Environmental Policy Commission

Presented by: Troy Biggs, PE, PH, D.WRE

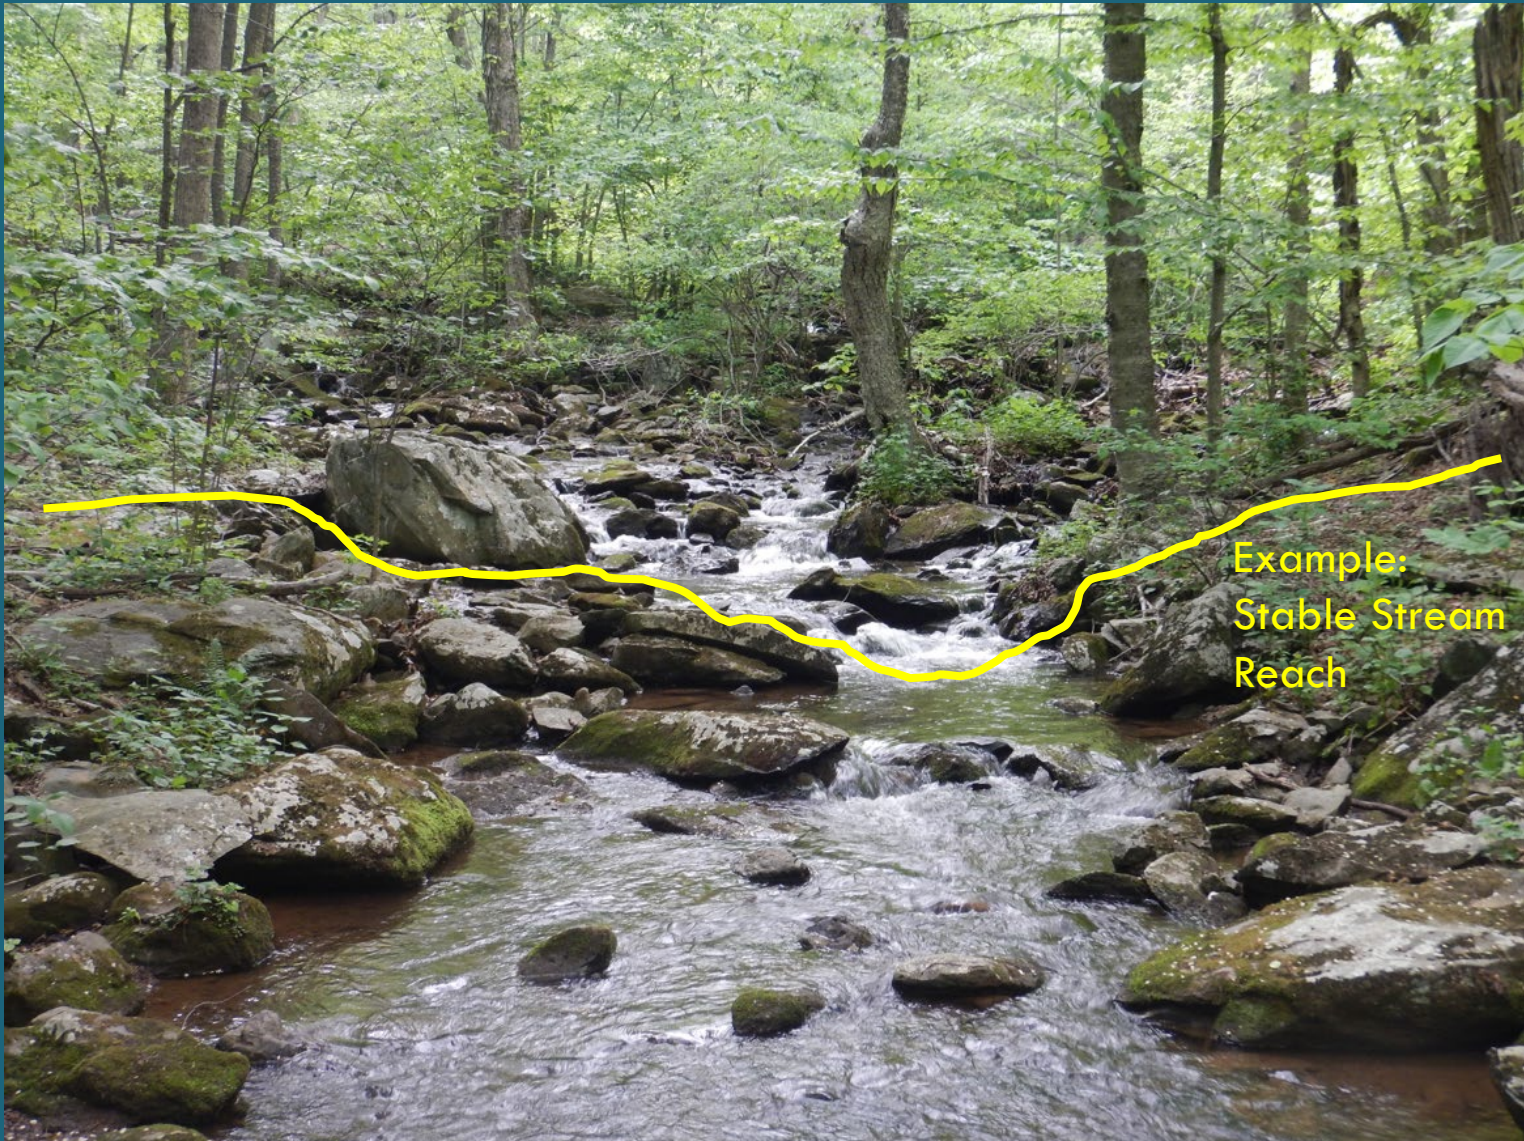
Overview Of The Problem

- Prior stream assessment (2008) identified the entire segment as having degraded conditions
- Developer led downstream segment stream restoration project performed the work as part of the Taft Avenue subdivision development completed in 2010
- Focused on 600 feet of stream from the bridge to Duke Street of City property
- Recent large storm events in the last three years have impacted the project and accelerated destabilization of the stream
- Forensic investigation to diagnose the nature and causes of bed and bank instability

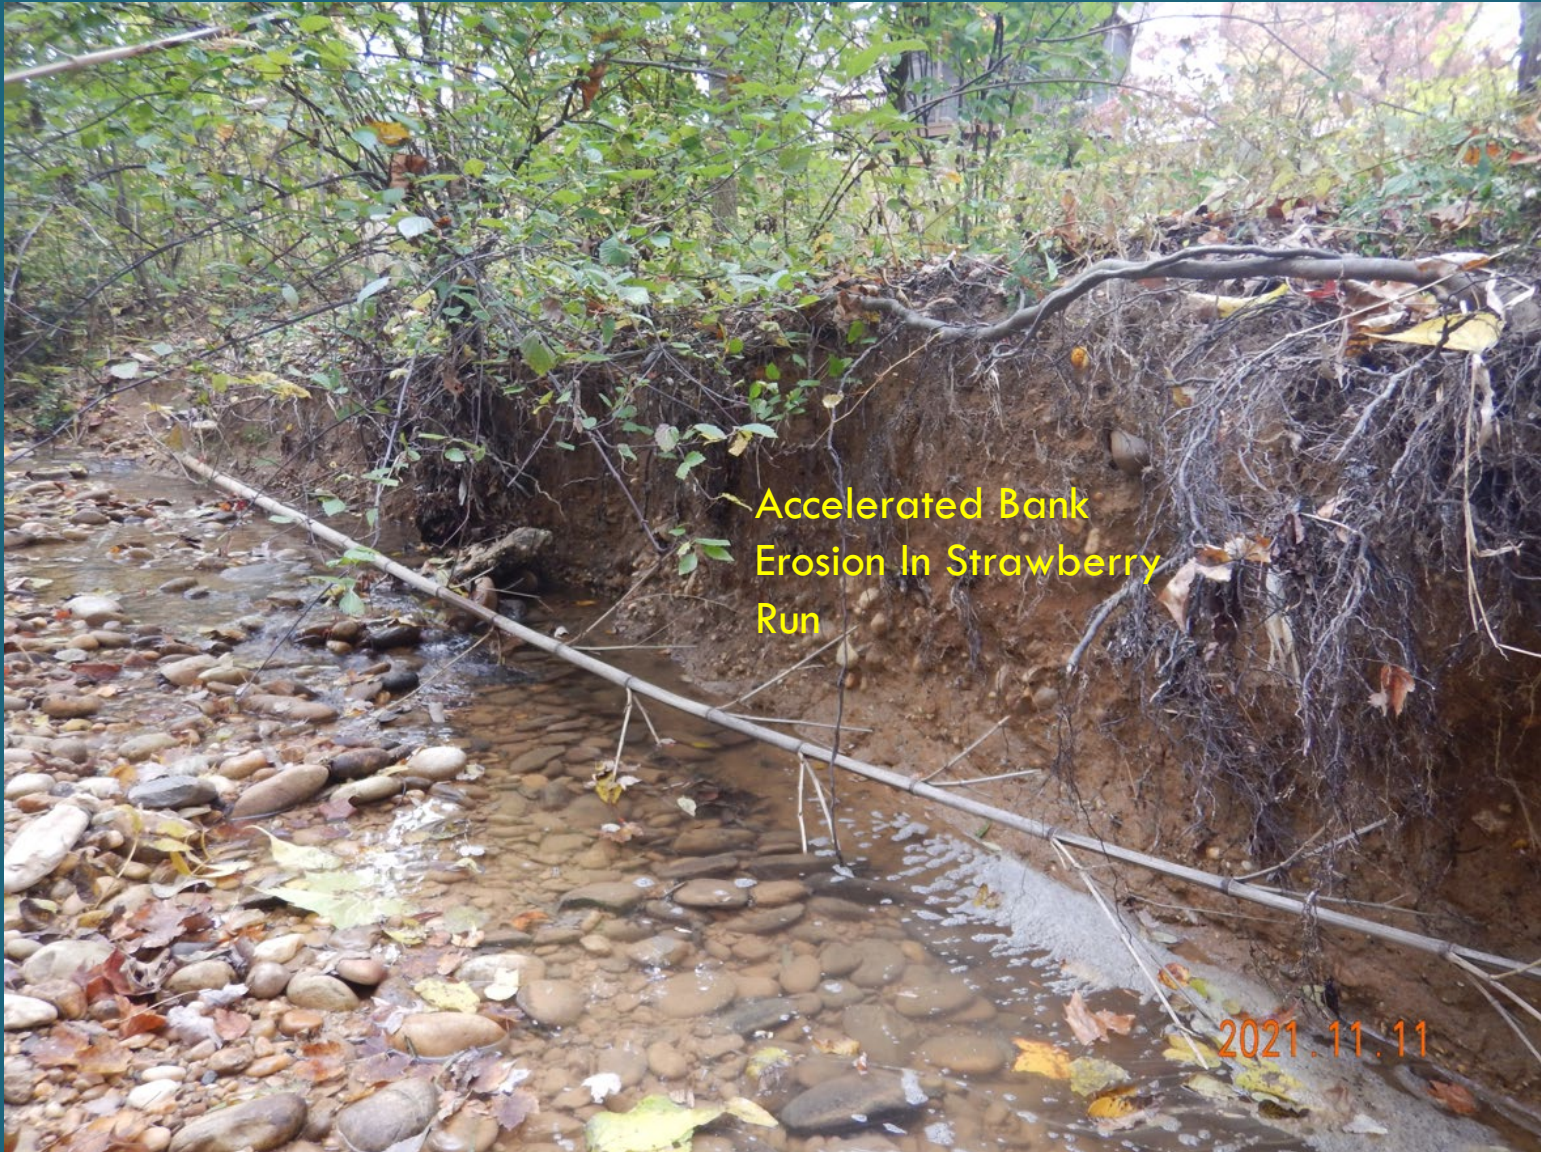
Channel
Incision In
Strawberry
Run

11/11/21 (Looking upstream towards pedestrian bridge)

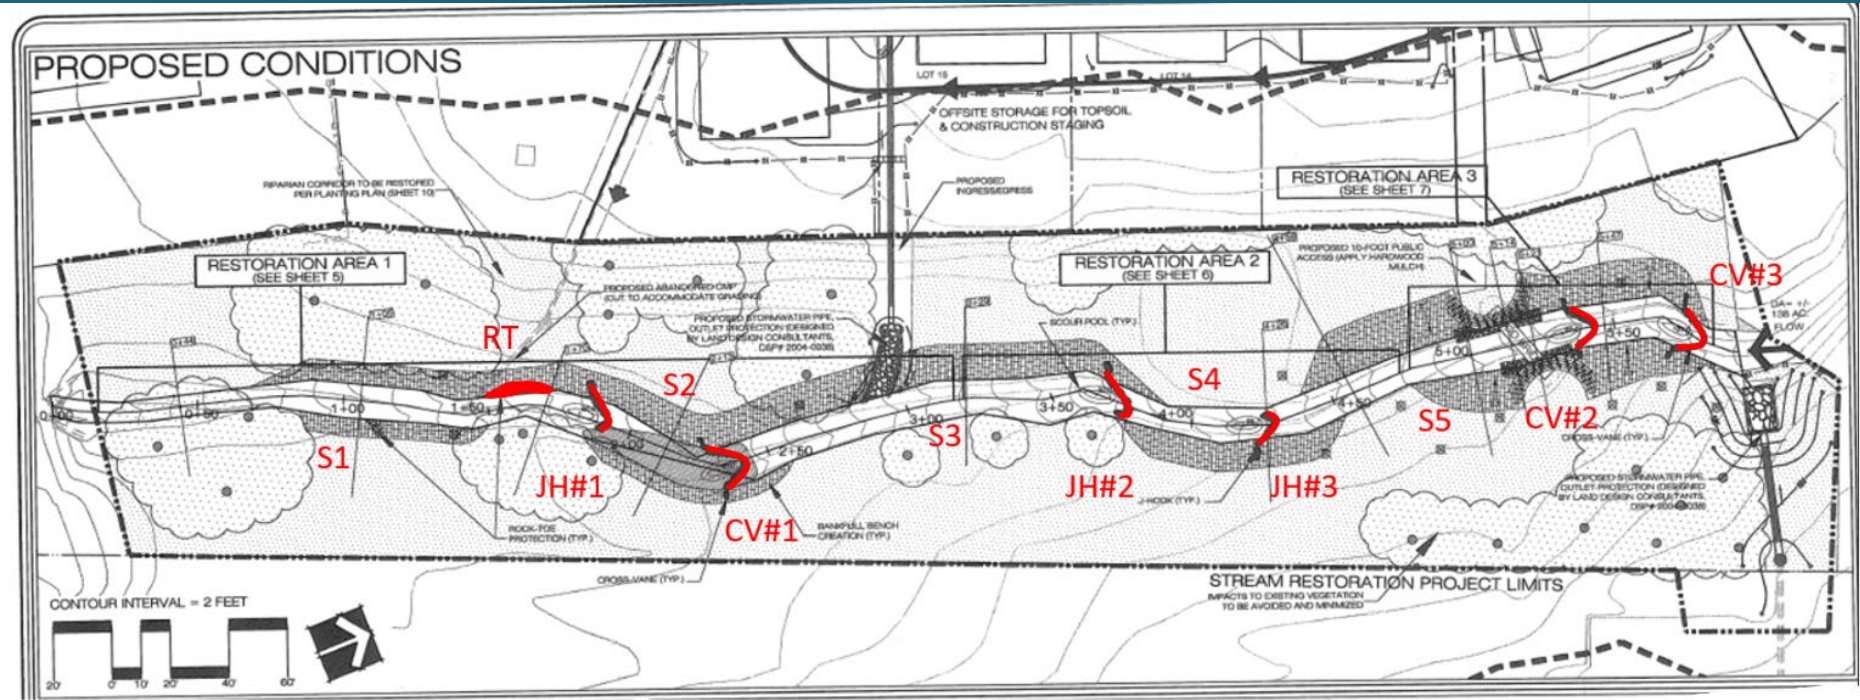
Solutions Proposed In 2008

Structures deployed:

- Cross-Vanes (CV)
- J-Hooks (JH)
- Rock Toe Retention (RT)

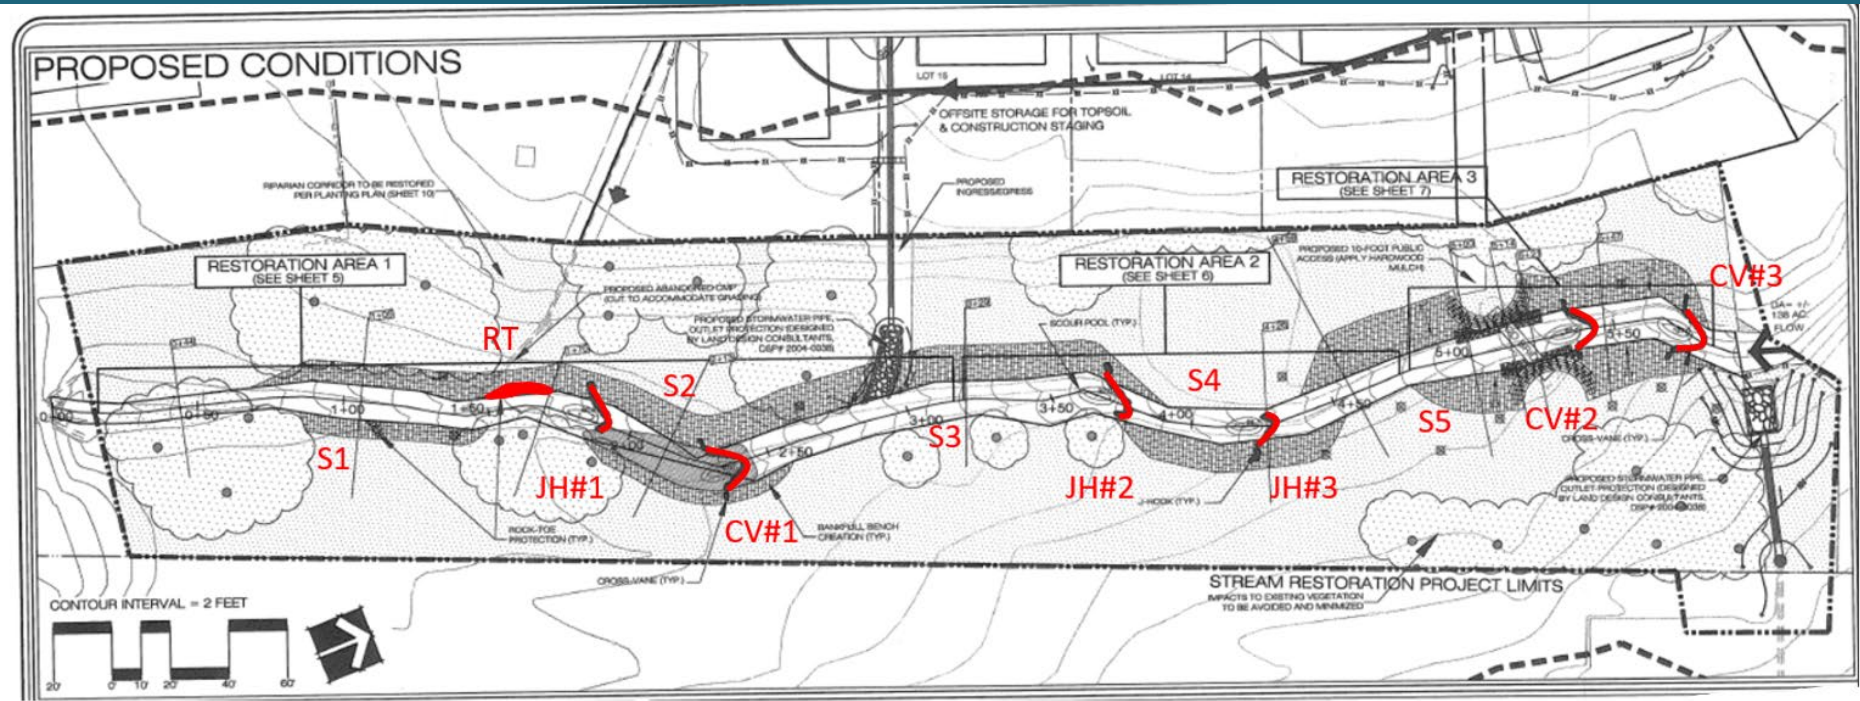
Solutions Proposed In 2008

Structures deployed:

- Cross-Vanes (CV)
- J-Hooks (JH)
- Rock Toe Revetment (RT)

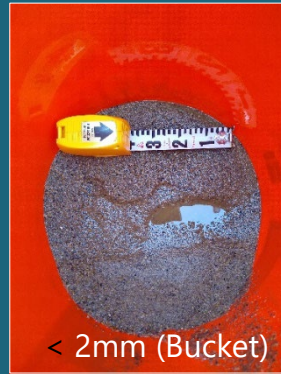
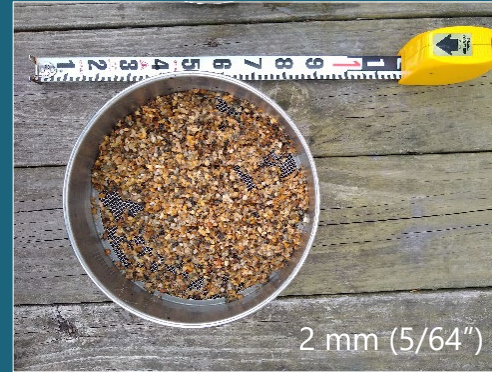
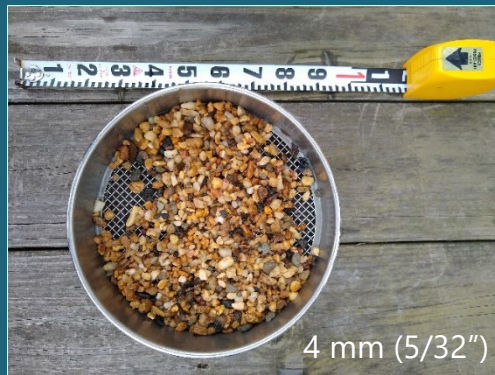
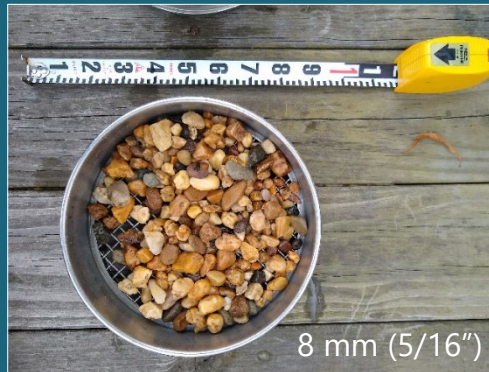
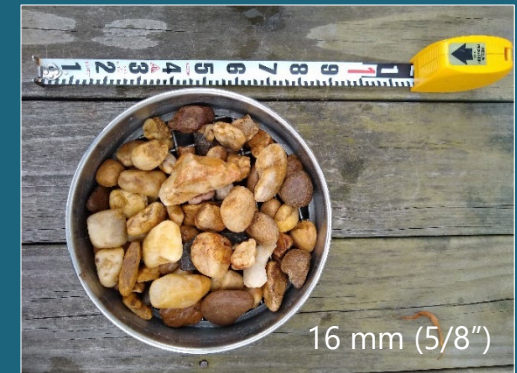
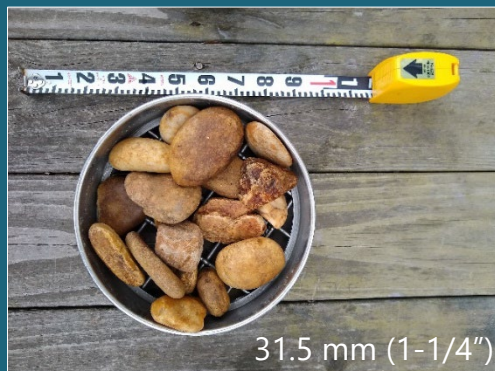
Size of Streambed Rock Particles

A little more than 1 foot of water in the channel nearly mobilizes the entire bed.

The biggest particle found was 110 mm. The 1-yr discharge moves approximately 200 mm particle.

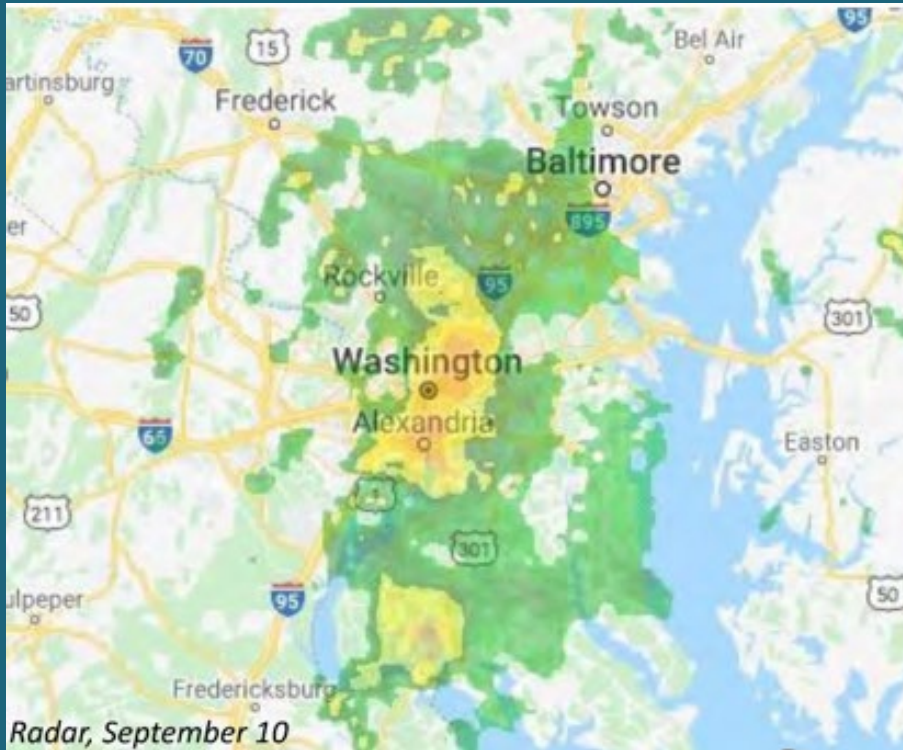
Climate Change: More Frequent, More Intense Storms

- One month post-construction in 2010, a 5-10-Yr storm event occurred
- Flash floods occurred:
 - July 21, 2018
 - July 8, 2019
 - July 23, 2020
 - September 10, 2020
 - August 15, 2021
